Allhallows MSCP is reborn following its £2.35m transformation.

Innovative remedial solutions used on a multi-million pound refurbishment of an ageing car park in Bedford culminated in the coveted 'Best Refurbishment Award 2015' at the British Parking Awards. Graeme Middleton of Makers Construction tells the story.

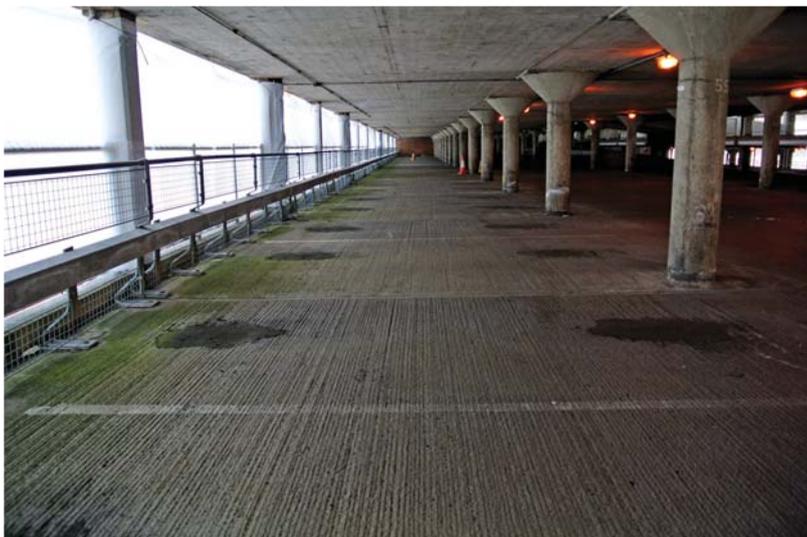
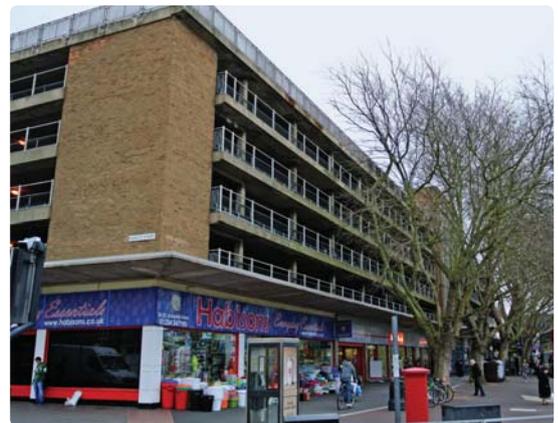
Poorly lit and unprotected from the effects of carbonation and salt-water ingress.

Allhallows in early 2013 before works commenced.

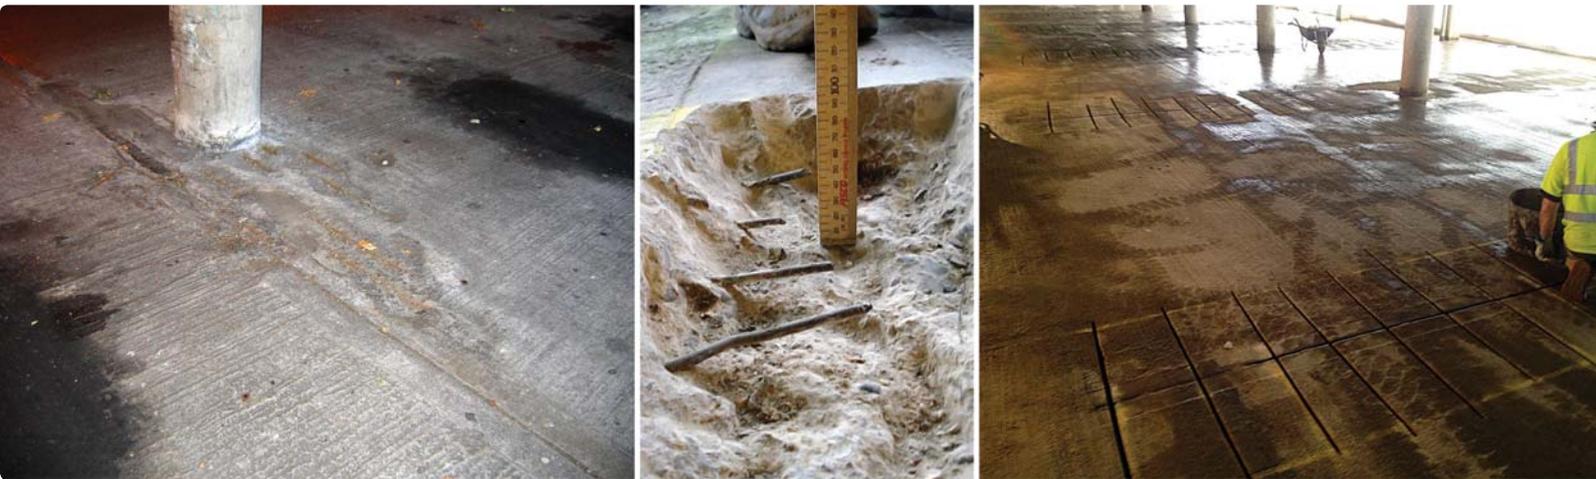
Extensive damage to daywork joints reveals significant loss of steel section.

intrusive surveys in 2010, which highlighted specific concerns over the volume of deterioration around the daywork joints and, in particular, within the older parts of the structure where the damage was much worse.

The damage was occurring to both the top and bottom reinforcement at the daywork joints with significant loss of section, where in some cases there was 100% loss. Electromagnetic anomaly detection (EMAD) technology was also used to identify anomalies, ie, where breaks in the continuity of steel were, enabling defects to be identified and mapped rather than having to embark on the laborious – and consequently expensive – process of destructive investigation to identify the extent of these defects.

The identified repair areas were marked up and saw cut around the perimeters to ensure square-cut edges to the proposed repair sites. Defective concrete was removed by hydro-demolition techniques to expose the corroding reinforcement, while at the same time removing corrosion product from the reinforcing steel. Drainage areas were netted over to prevent them from becoming clogged with the concrete spoil being cut out.

‘Lost’ steel – particularly in the daywork joints – was replaced with new. Part of the remedial structural solution was also to cut 1200mm-long × 50mm-deep chases perpendicular to the daywork joints at 300mm centres into which 1000mm-long × 12mm-diameter reinforcing bars were grouted and ‘weighed down’ while curing to prevent the vertical expansion of the grout and possible displacement of the new steel. General repairs to the concrete decks were carried out using a pre-bagged and pourable cementitious repair mortar.

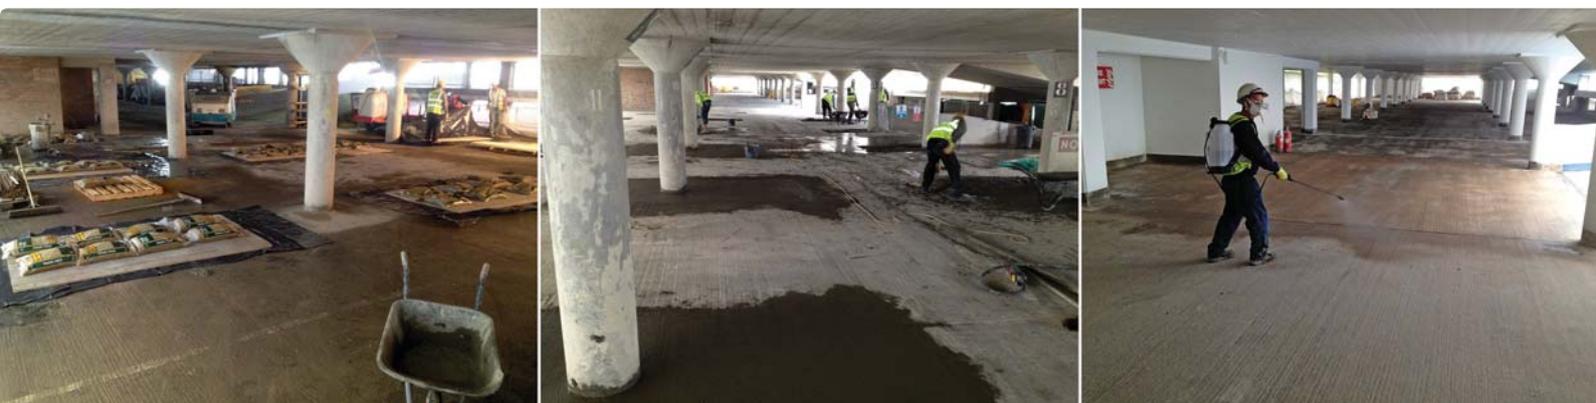
Further investigations highlighted structural concerns over the volume of concrete degradation and steel corrosion around the bases of the columns and to the top steels located in the decks around those areas.

Major repairs at joints and column bases followed by the application of a migratory corrosion inhibitor.

Following all concrete repairs and thorough surface preparation through captive blasting, a migratory corrosion inhibitor was spray applied to the parking decks throughout as part of the corrosion management system, ensuring long-term success of the concrete repair strategy.

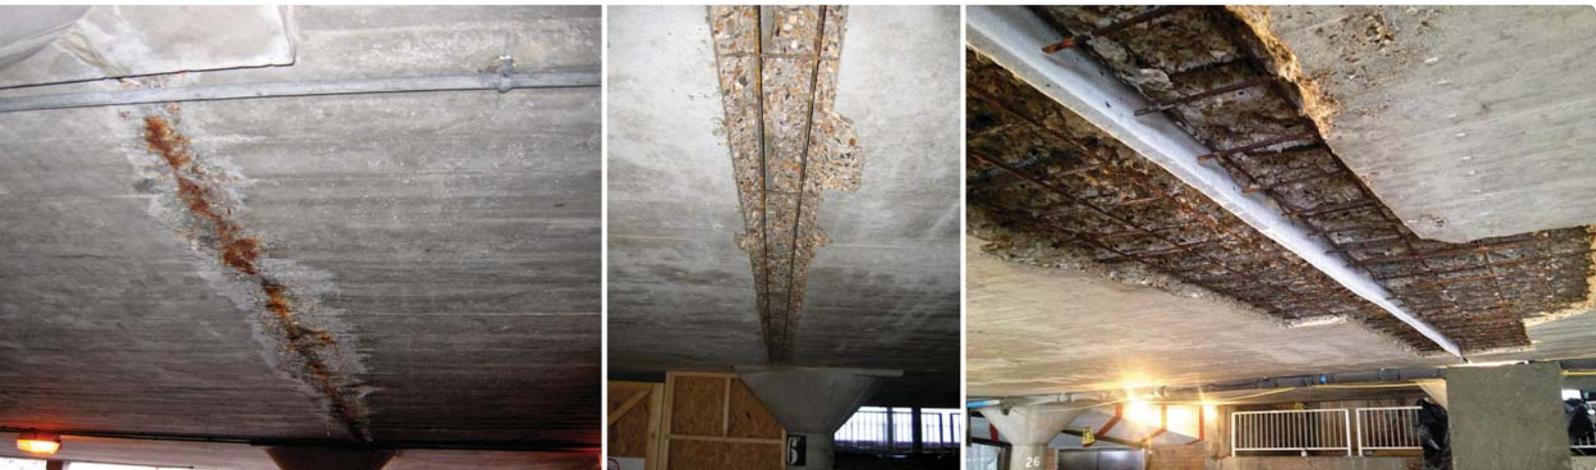
Significant soffit damage at daywork joints.

With an existing ‘shutter finish’ to the soffits of the car park, which had to be retained as a design feature, timber rails were fixed to either side of the soffit joints to enable them to be neatly cut out before preparation and reinstatement using a spray-applied, pre-bagged cementitious repair mortar.

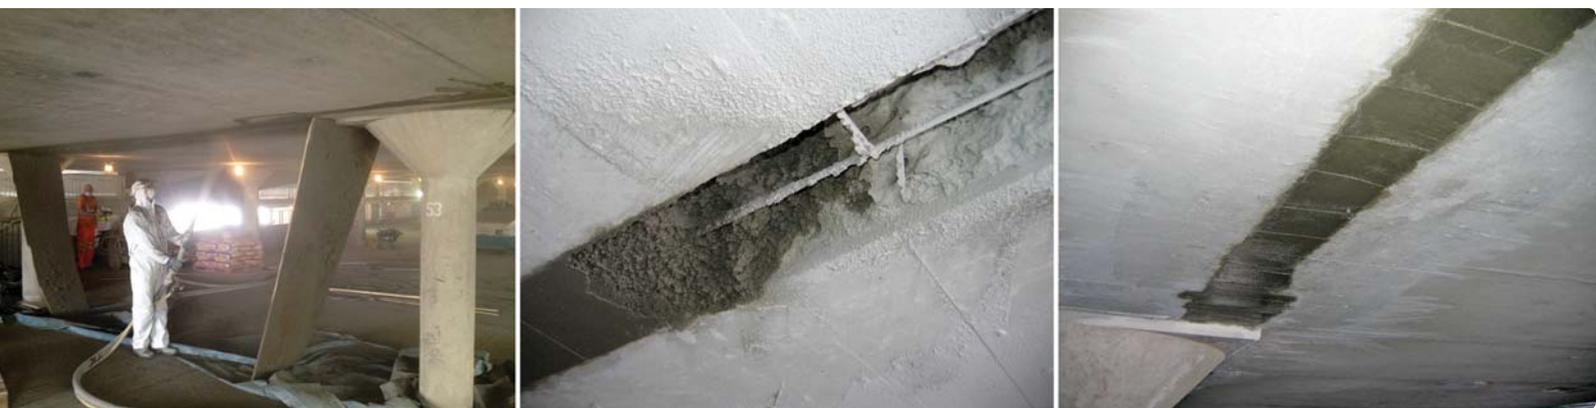
Above: Soffit repairs spray-applied and blended in.

Once sprayed, the excess overspray was trowelled off and following initial set, the board finish was recreated by hand to disguise and blend in the repairs. Not only did this mean that the repairs were ‘aesthetically neutral’ (ie, you can’t see them), it also gave a significant time- and cost-saving benefit for the repairs required.

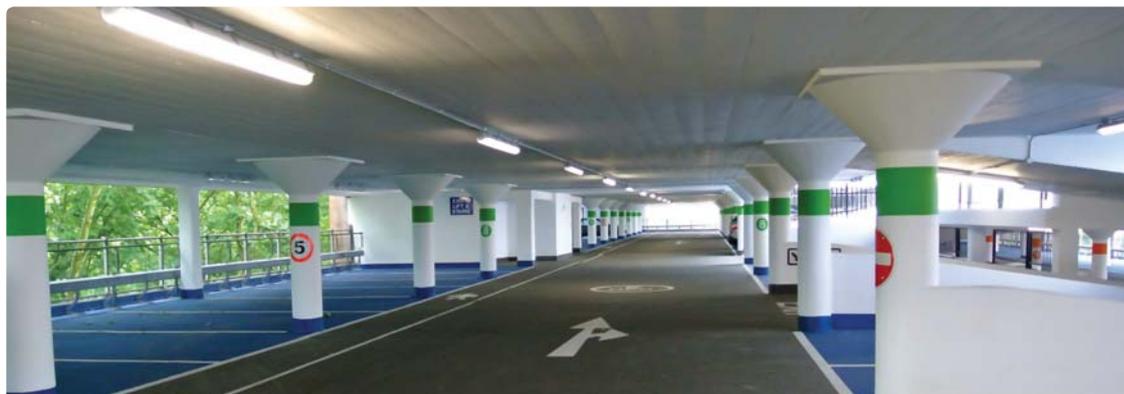
The dark, drab interior is given a new lease of life.

All non-trafficked concrete soffits, columns, beams and walls were protected with white anti-carbonation coatings to enhance the lux levels and maximise light reflectance for the new energy-efficient passive infrared sensor (PIR) inducted lighting system that was installed as part of the contract.
