CASE STUDY

Car Park Refurbishment

Coptfold Road MSCP

Multi-storey Car Park

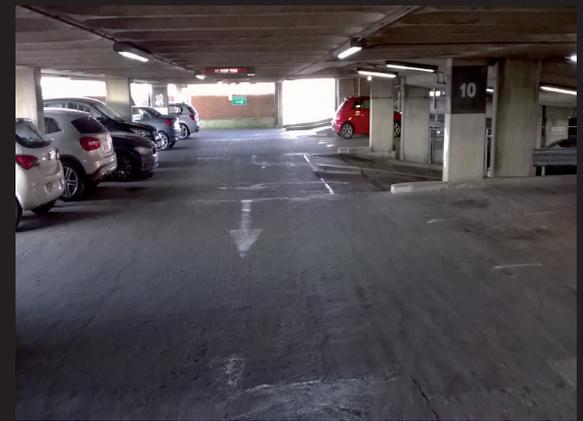
Before

Coptfold Road Multi-Storey Car Park was originally built in 1972 with its concrete framed structure and brick outer skin, it consists of eight storeys with split levels and interconnecting ramps, providing 555 spaces. With floors of reinforced concrete waffle construction, it was showing signs of corrosion and spalling to the soffits with extensive wear and tear to the decks over the years.

The structure was found visually to have deteriorated and exhibited distress in some areas, with the exposed surfaces found to be variably weathered and discoloured, generally consistent with concrete elements cast and exposed in this environment for in excess of 40 years.
