# CASE STUDY

## Car Park Refurbishment

ASDA Worcester

Steel Frame with  
Concrete Slab

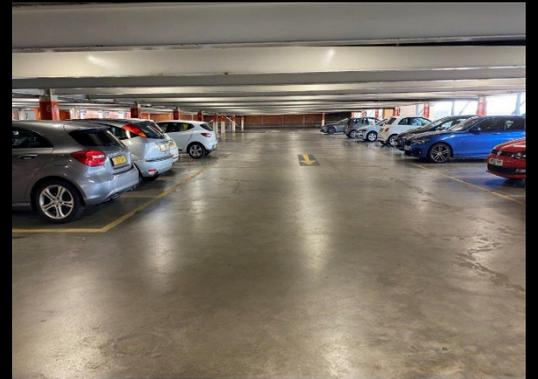
The steel frame concrete slab structure shares the same façade as the Royal Artillery building, home of the Territorials. The 8-level multistorey was suffering from highly polished floors, which when wet through with rain deposited by cars, made the car park a skating rink. The top deck levels 7-8 required asphalt and joint repairs as well as drainage works to prevent water ingress to the structural steelwork.

Before

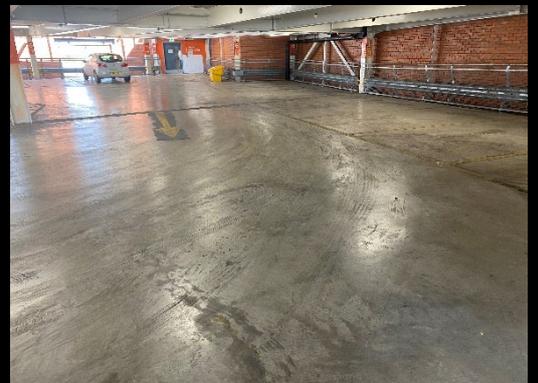
Before

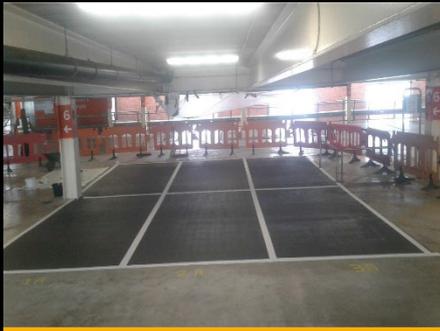
Testing

Following the preparation, the substrates where tested and all passed the 1.5KN/mm<sup>2</sup> test required for the application of the Triflex system.

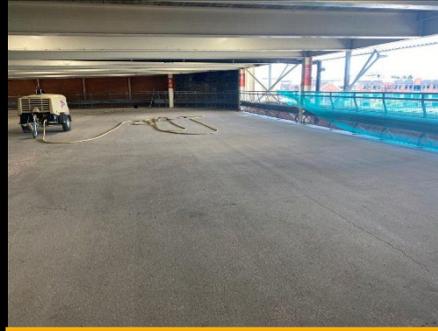
Double Blasting

The 3 different types of preparation consisted of in trial 1 A plane and blast of the surface. This a mechanical planner which removes 4-5mm of the top surface and then is captive blasted, trial 2 using the captive blast machine to blast the top surface twice to create a key, and trial 3 a single pass of the captive blast machine.

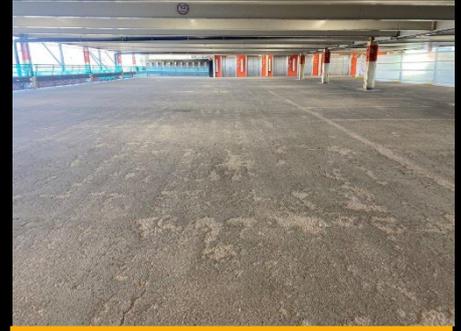
180° turn from Test Area

But preparation was carried out on the same deck 180 degrees turn from the test area and the result was startlingly different.

The top crust had been blasted to form a key but had also given itself up, losing up to 5mm of material creating a very uneven and friable surface. 8 test sites were located across the area and the results were poor with over 60% of them failing and not achieving the required 1.5kn/mm<sup>2</sup>. After closer examination the "cauliflower" effect left very friable edges at the points of transition which very quickly would debunk and fail causing a failure of the system if applied.

The decks original construction is inconsistent with very distinct areas, and the resulting surface after the double blast showed a moon crater effect, with clear channel lines indented which were originally thermoplastic lines, and when blasted removed 5mm of the concrete topping.

The solution was to plane off the residual crust to get down to the better substrate which had already been tested producing adhesive results in excess of 3Kn/mm<sup>2</sup>.

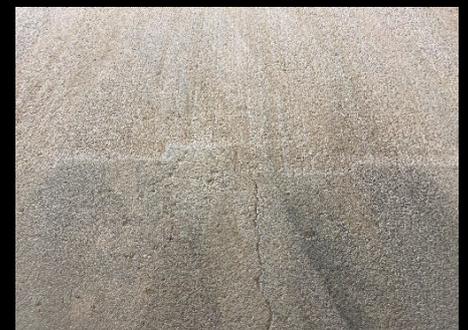
The contract programme starts with the agreed specification and tender process, however, after progressing further directly to the right of the original test area the surface was consistent with the polished crust removed and the residual intact and bonded. Cracking was evident within the top of the surface and this was also seen during the trial.

Surface Cracks

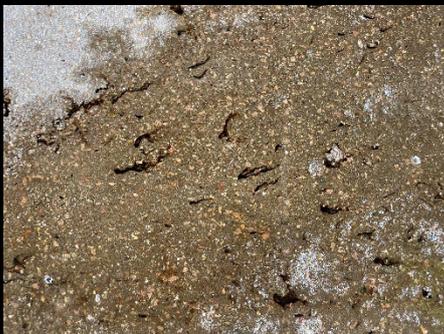
On close inspection of the substrate the slab was suffering from "Lignite", this is a rare occurrence whereby iron ore aggregate has contaminated the mix. The issue with Lignite is if it gets wet it creates an acid that burns through the deck system, causing blisters and pockets under the surface.

The voids/holes within the surface were between 2-3mm deep and were caused by Lignite which is small fragments of coal ore which had probably been caused by not cleaning out batch plant when mixing concrete. These deposits are inert but when they come into contact with water, they produce black soluble solution. This reaction was immediate and once dried the black powder was air blasted away, leaving the issue of voids or craters in the substrate which could lead to outgassing during the installation process. Outgassing is when the resin as it cures forms a bridge or skin across the hole to which the rest of the system is applied. Unfortunately, the area directly below the bridge is hollow and unsupported which allows the moisture and oxygen vapour to expand when it's heated through thermal gain and as it expands, it bursts through the system causing "pin holing".

Pin holing is not detrimental to the performance of the system and would not be seen by the naked eye, but over time gather dirt and leave a speckled effect in the brighter coloured coatings. On the black and adorned grey not so obvious but as we were not producing a waterproofing system it wasn't a problem and the system was being installed for safety and aesthetics.

Lignite

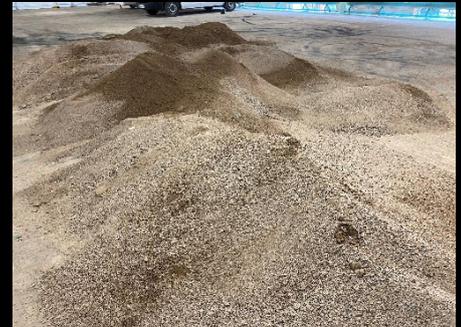
Spoil

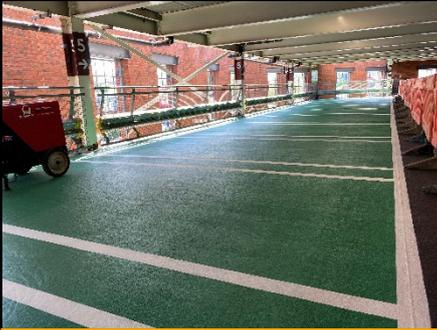
After

The top deck required various minor repairs such as installation of movement joints, drainage repairs, making upstands watertight, movement and reinstallation of guttering and trolley bays were refurbished with coatings. After repairs were carried out the top deck received refreshed line marking installed throughout.

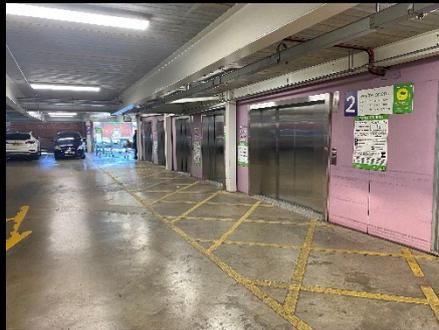
Before

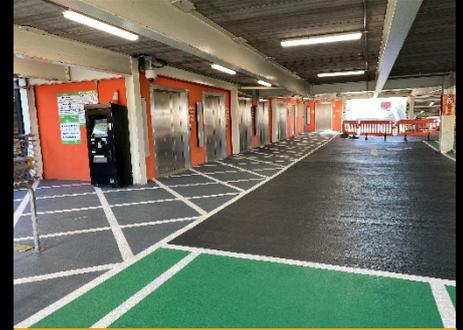
After

Each level 1- 6 required surface preparation of the concrete deck to ensure best rests of the installation of Triflex DeckDefence ECO. All levels were prepared using Schibeci to remove lines and shot blast.

A self-priming coating layer was installed which is the resin the quartz sand is broadcast into, embedding into the resin to provide slip resistance properties. Once fully cured the excess sand was swept off with a sweeper before installing a wearing/seal.

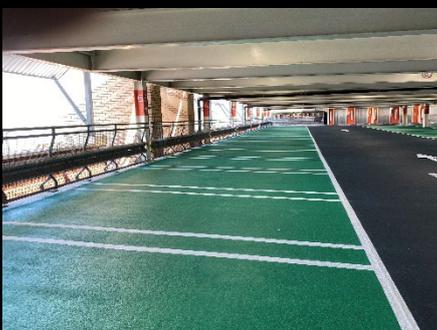
After

All areas were taped off in preparation for the Triflex DeckCoat system; wearing/seal coat containing the required colours which is poured onto the deck and applied to the surface areas to specified consumption using a squeegee and then back rolled, providing a coloured sealed finish.

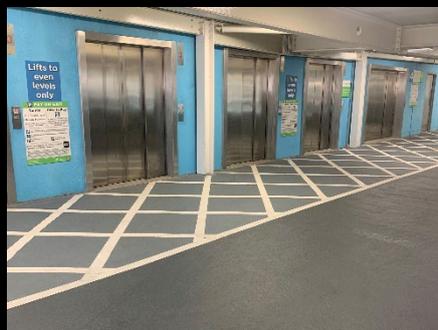
After

The standard 2.4 metre bays were widened to 2.6 to provide easier parking and offer better customer parking experience. Where required trolley bays were refurbished with new furnishings and new line-markings and directional arrows re-instated throughout.

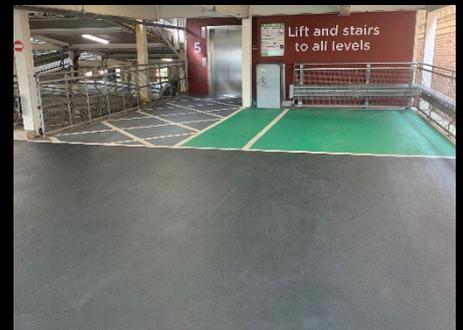
After
