STRUCTURES CASE STUDY

Roofing for Shopping Centres'

Kingfisher Centre, Redditch

Shopping Centre 'Warm' Roof

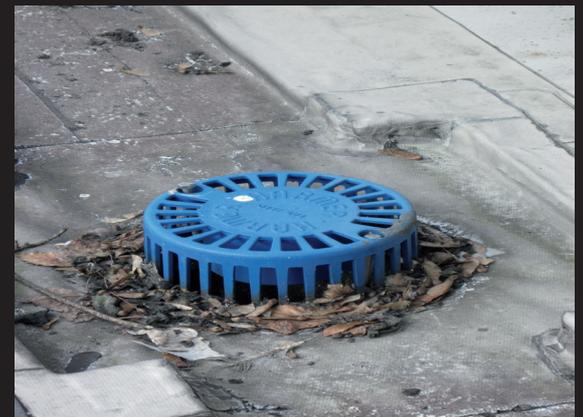
Before

Re-waterproofing works were required to constantly leaking 'warm' roofs over two retail units at Kingfisher. The existing single-ply flat roof waterproofing system not only had failed seams & lap joints across the centre's roof but it had been patched up over several years but which had never properly resolved the water ingress issues.

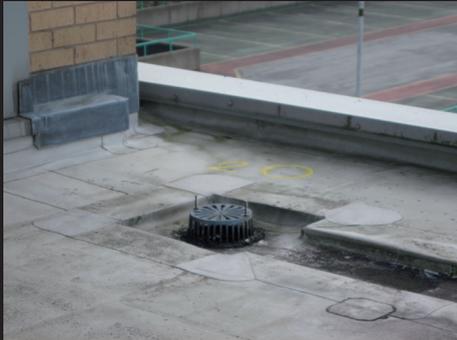
Failed detail in gullies

The major contributor to the leaks through the centre's roof were multiple repair patches that had previously been applied to visibly damaged areas and failed seams of the roof but these patches had also failed. The majority of the failed repairs were in detail areas such as perimeter upstands, HVAC plinths and gullies. Blocked drainage gullies holding water over failed lap-joints in the existing single-ply roofing system were also contributing to the water ingress problems.

In order to ensure 100% adhesion of the Triflex system to the existing failed substrate, the entire surface area was power washed to remove all existing surface dirt and contaminants that had built up over a number of years. The first coat of Triflex ProTect was applied and whilst wet, Triflex reinforcing fleece was added and 'rolled in'. This was then fully encapsulated by a second coat of ProTect. The encapsulation of the fleece reinforces the roofing system ensuring that previously failed seams and laps are properly bridged. Even at detail areas, the liquid-applied waterproofing is completely seamless and fully bonded to the parent substrate, so is ideal for re-waterproofing, overcoming complex detailing and terminations.

In order to ensure continuity of the seamless waterproofing underneath plant, oversized pre-coated boards were inserted and Triflex fleece was then dressed up and over the edges and encapsulated within the Triflex coating. Similarly, the reinforced coating was dressed down and through the drainage gullies meaning that now, even if there was standing water, the gullies are seamless and so water cannot get through into the building. A 1200mm wide walkway was also applied in a contrasting colour with a slip-resistant finish to highlight designated & safe walkway areas around the roof.

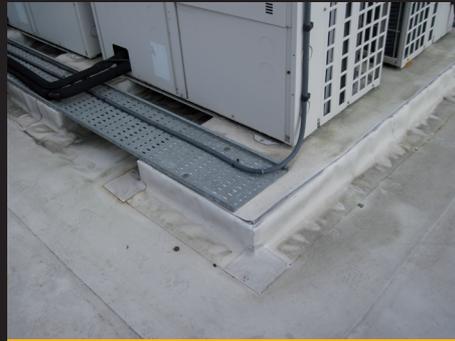
Failed patching on plinths

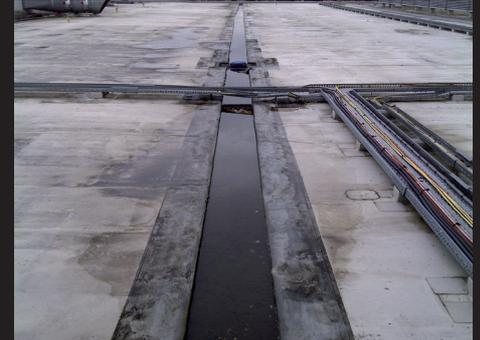
Gullies holding water

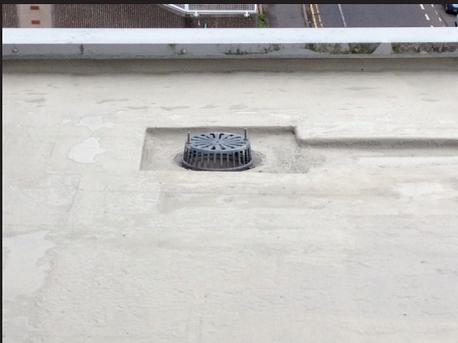
Gullies now watertight

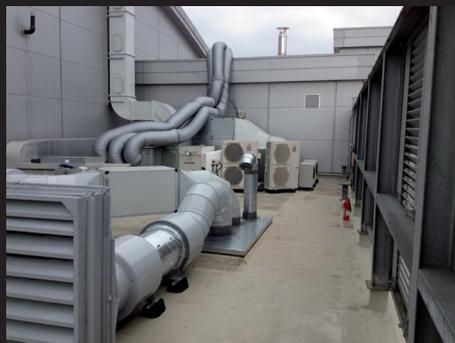
Plinth detailing complete

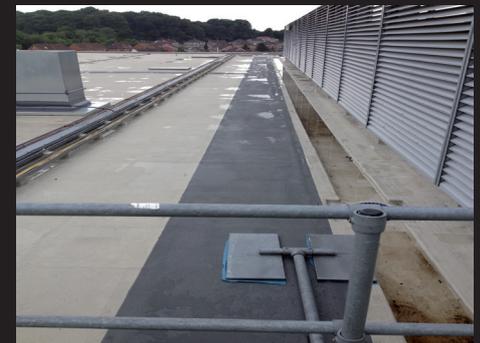
Safe, slip-resistant walkways
