CASE STUDY

Structure Repair, Corrosion MCI & Coatings

The Quadrangle Cheltenham

Commercial and retail building

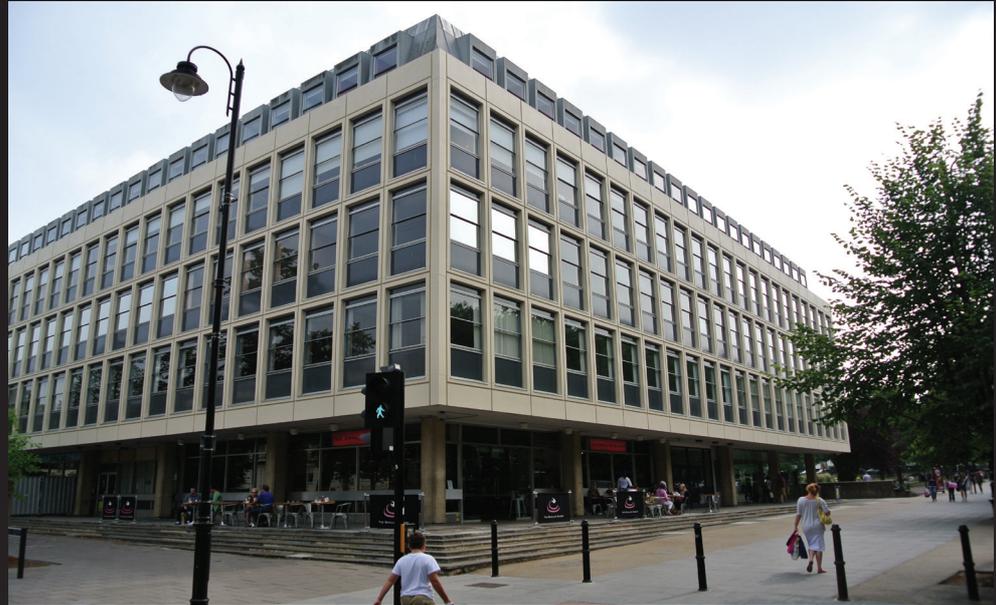
The reconstituted stone storey height panels were highly carbonated which allowed heavy corrosion of the embedded steel reinforcement to occur resulting in the spalling of significant sections of the facade. The missing and damaged sections had to be brought back to the original profile to ensure the integrity of the structure.

The repair works were carried out using the Sika Monotop system. Prior to placing repairs the exposed steel reinforcement was grit blasted back to clean steel and the repair site brought back out to its original profile using hand placed techniques.

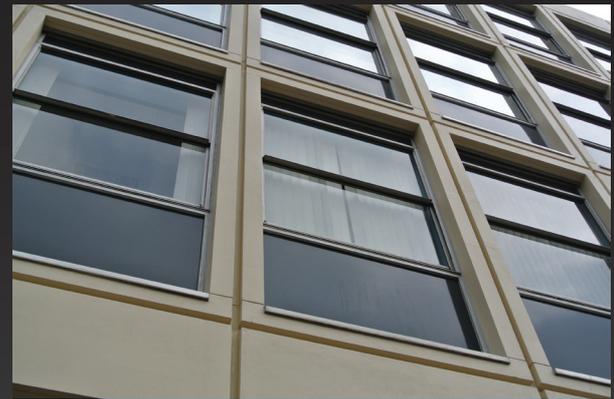
Repaired full storey facade panels

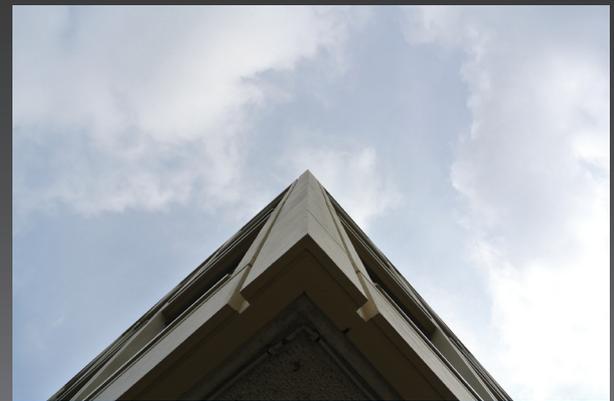
Finished Detail

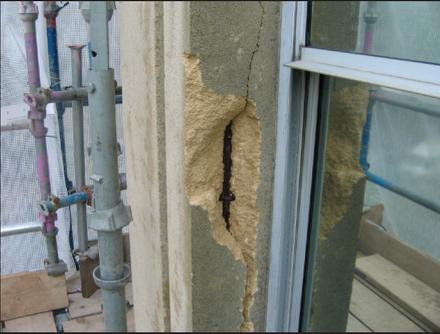
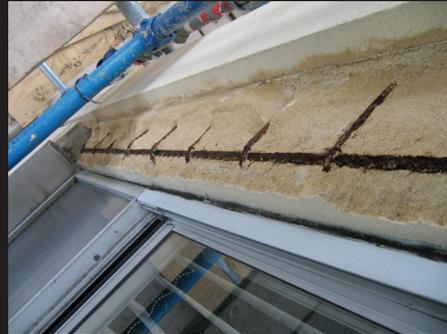
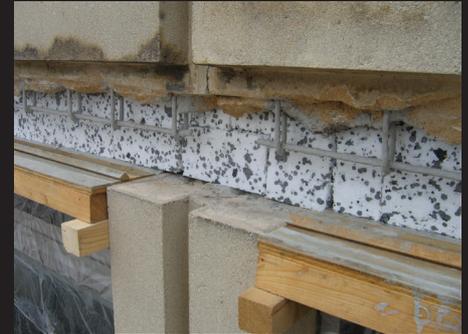
A high pressure water jetter was applied to the external surface to remove the laitance and then hammer tested to reveal the extent of the required repair. Carbonation and chloride tests were undertaken and sent off to the laboratory for analysis and used to aid design.

Loose and de-bonding facade were removed to expose the corroding steelwork and then the surrounding concrete was removed to expose the affected steel which was cleaned and prepared before receiving a slurry primer.

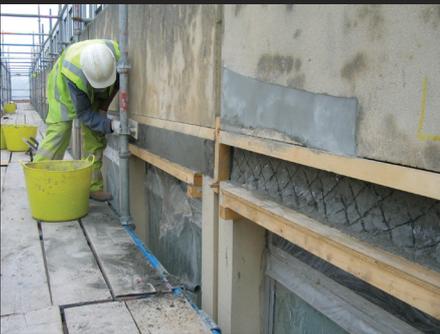
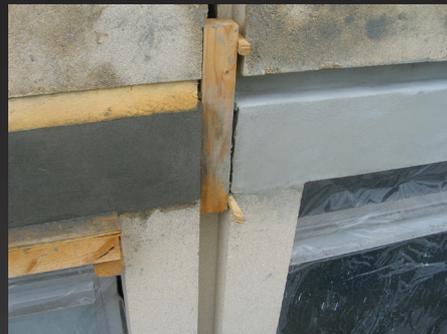
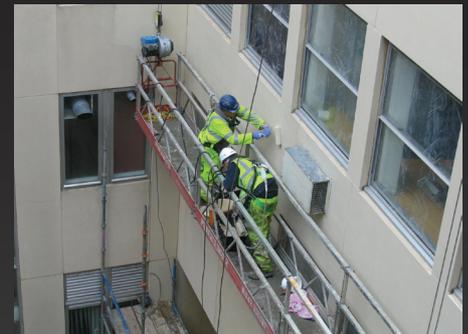
Pre-blended proprietary repair system was hand placed to the required depth to ensure the repairs were built out to match the existing profile. Migratory corrosion inhibitors were applied to arrest any further deterioration through chloride attack and once cured the repairs were masked with the application of elastic anti-carbonation coatings to provide protection to the whole of the structure. This transformed the building's outward appearance using a sympathetic colour to blend in with the surrounding regency architecture.

The building was made watertight by replacing the old movement and window joints with high performing, low modulus sealants which ensured the total treatment of the facade at its weakest points.
