CASE STUDY

Structure Repair, Corrosion MCI & Coatings

The Quadrangle Cheltenham

Commercial and retail building

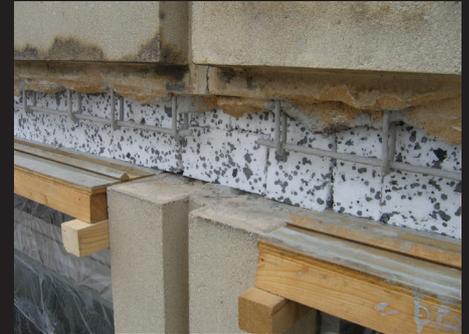
A high pressure water jetter was applied to the external surface to remove the laitance and then hammer tested to reveal the extent of the required repair. Carbonation and chloride tests were undertaken and sent off to the laboratory for analysis and used to aid design.

Loose and de-bonding facade were removed to expose the corroding steelwork and then the surrounding concrete was removed to expose the affected steel which was cleaned and prepared before receiving a slurry primer.

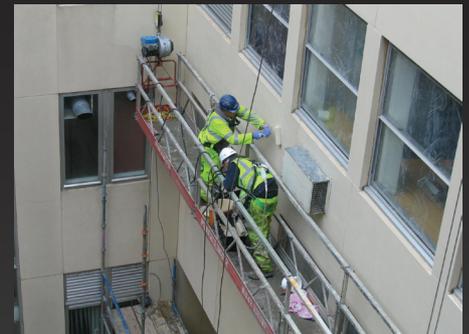
Pre-blended proprietary repair system was hand placed to the required depth to ensure the repairs were built out to match the existing profile. Migratory corrosion inhibitors were applied to arrest any further deterioration through chloride attack and once cured the repairs were masked with the application of elastic anti-carbonation coatings to provide protection to the whole of the structure. This transformed the building's outward appearance using a sympathetic colour to blend in with the surrounding regency architecture.

The building was made watertight by replacing the old movement and window joints with high performing, low modulus sealants which ensured the total treatment of the facade at its weakest points.
