# CASE STUDY

## Car Park Refurbishment

TESCO Merthyr Tydfil

Steel Frame

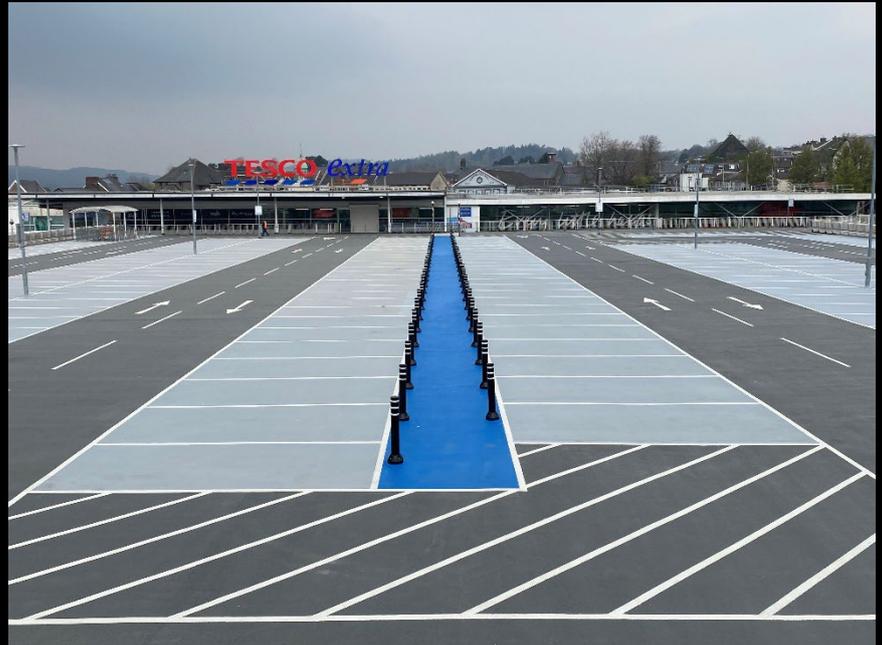
Tesco Merthyr Tydfil is a car park constructed from a steel frame, precast concrete planks, together with a structural topping receiving 40mm of asphalt providing a protective waterproofing layer.

The steel frame was constructed so that a single fall from the store to the end of the car park collected rainwater run off in one large singular curved gutter. This gutter was poorly constructed allowing water to bypass between the steel frame and gutter supports resulting in heavy corrosion and large volumes of water dropping onto vehicles below.

The existing asphalt layer had a heavy stone content but was suffering from splits and adhoc repairs which had failed resulting in water penetration and the formation of stalactites on the soffits below. Continued water penetration had caused the existing painted steel structure to corrode and begin to lose sectional thickness.

The project required the removal of 550 tones of asphalt, the preparation of the slab through captive blasting, applications of pre-primer to reduce the effect of out-gassing, banding reinforcement to all day joints and cracks and the application of a fully fleeced WestWood Wecryl system.

The contract commenced in September where the top deck was totally closed to allow the removal of the asphalt. Once prepared 50% of the deck areas received a primer and sand coat to protect the structural topping and then opened to the public, the remaining 50% received the full system.

After the required departure from site to accommodate retail requirements the remaining 50% of the car park was completed.

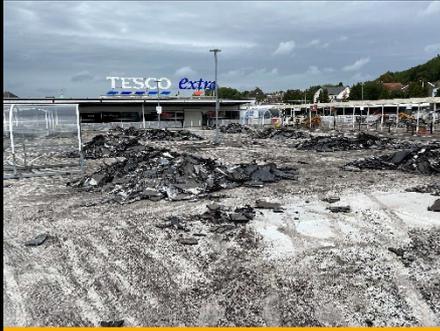
Asphalt Removal

During the removal of the 550 Tonnes of asphalt process, water was discovered beneath the asphalt with cracking in the slab traversing the walkway. This left no alternative than to remove the asphalt and deal with substrate issues. It was also evident that when the car park was built, the structural topping day joints were created directly above the supporting beams which when cracked provided a direct route for water to hit the metal steel work. The deck was blasted removing friable material from the top surface of the slab and so the slab was pre-primed using WestWood's pre-primer to ensure that there was enough bond strength and structural topping to provide a suitably strong surface to apply the waterproof system. Once repaired it was waterproofed using the WestWood fully fleeced system. This was particularly important as the slab is likely to have a significant degree of movement and the banded, fully reinforced system is designed to copy with the movement expected from such a car park design.

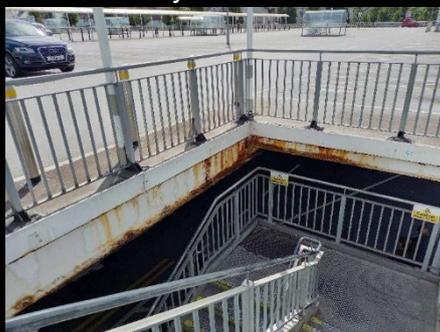
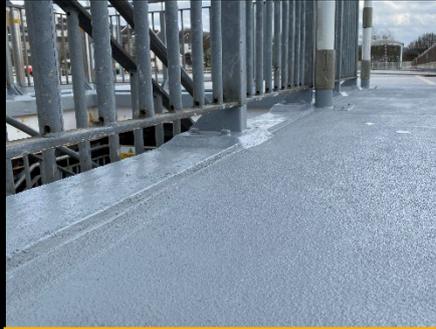
Stair Cores

The car park is served by 3 stair cores each of which were suffering from the ravages of the weather and corrosion which were unsightly and needed improvements to physical appearance. This was caused due to no drainage within the structure and water cascading down the stair cores. The original intention was to leave the asphalt in place around the stair cores but after removal of the other areas the asphalt had become de-bonded and as such had to be removed. This created a water control issue and so using WestWood's Wecryl 242 product, screed diamonds were created to direct water along the sides of the stairwells. This was combined with installing fleeced trims to prevent water from travelling and falling into the public stair cores. The cores were treated and then subjected to new coatings to protect the steel and extend the life.

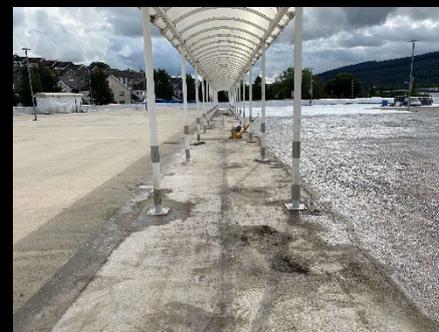
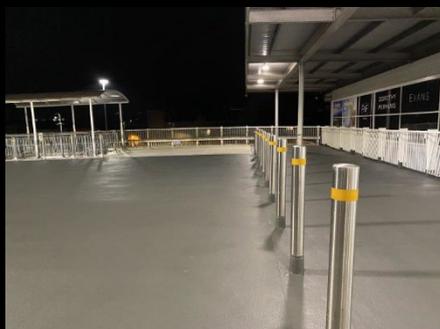
Walkway

The canopy and walkway area falls towards the store and the ramp from the store entrance falls in the opposite direction and without any drainage and the subsequent change in levels this meant that there would be a ponding issue where both positions intersect. We introduced a drainage outlet in this area and a pipe into the rainwater system below to alleviate this situation.

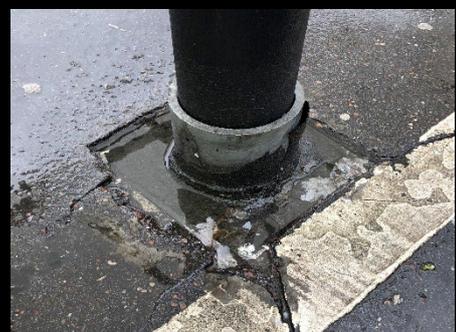
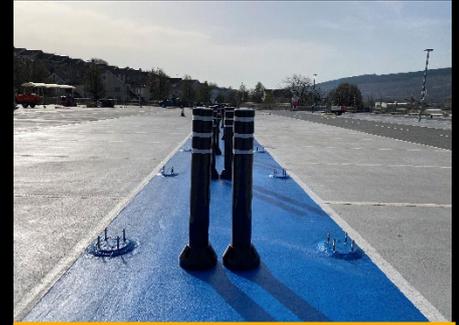
Bollards

The walkway canopy and bollards were removed, on removal of the bollards it revealed that the fixings to many of the bases had corroded and that they were reliant on the asphalt holding them in place. New bollards sourced from Watts Polyurethane which come in component parts and consisted of a cast base plate which is resin fixed into the slab. They were fitted directly onto the WestWood's fleeced layer. Once drilled and resined into position the plate was then dressed and filled to ensure it was watertight and then sealed in and bonded to the remaining membrane system.

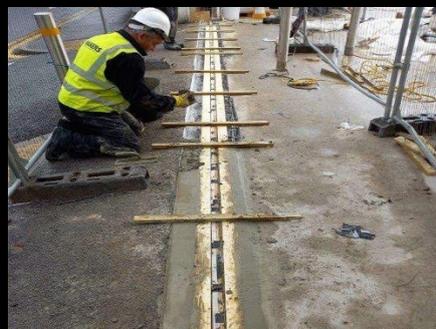
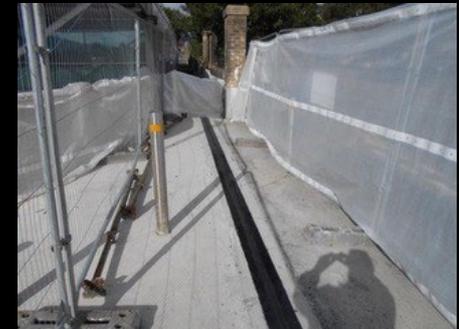
Ramp Transition Joint

The car park had a transition between the ramp and parking deck and also at street level where vehicles can exit the car park. Both areas were causing significant issue for the steel work below as they had been allowing water to penetrate the structure causing heavy corrosion to the structural members. An Emseal™ gland bridge joint was installed to remove the issue.
