CASE STUDY

Car Park Refurbishment

IKEA Wembley

Multi-Storey Car Park

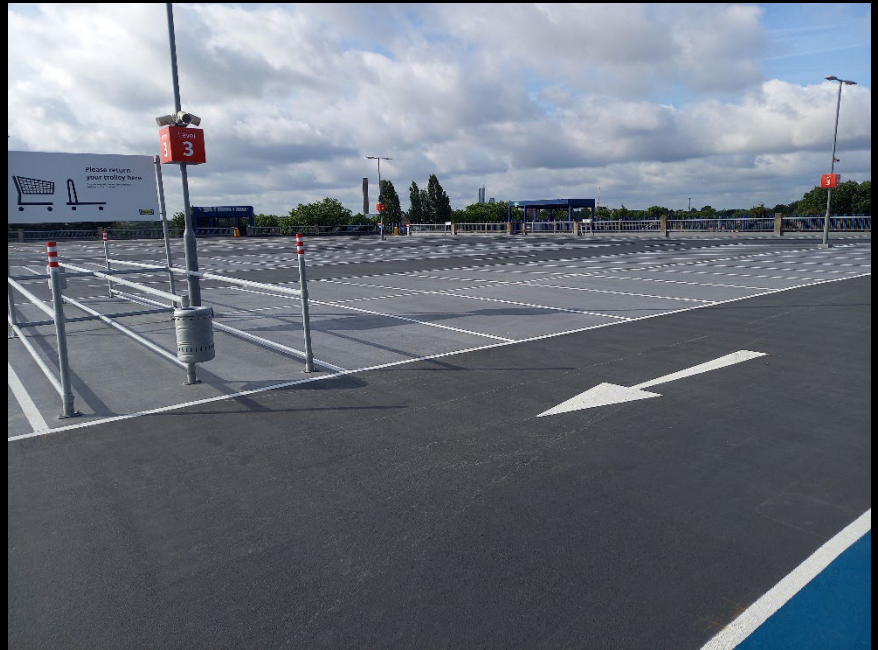
Makers were called in by IKEA Wembley to examine the issues with the multi-storey Car Park. European Headquarters to UK and Ireland. The car park was suffering from significant water penetration causing repairs to the concrete frame and severe ponding and car damage to the deck directly below.

Makers returned in 2022 to carry out a significant refurbishment to the external top deck during the makeover phase of the existing store.

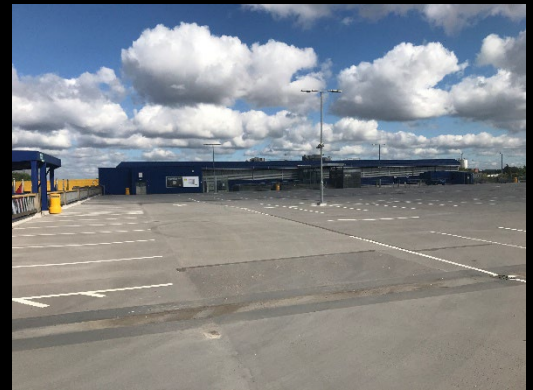
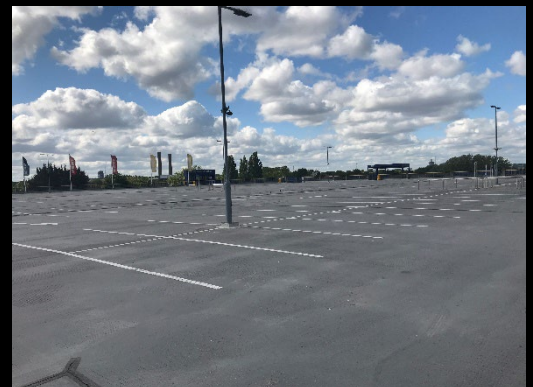
Before

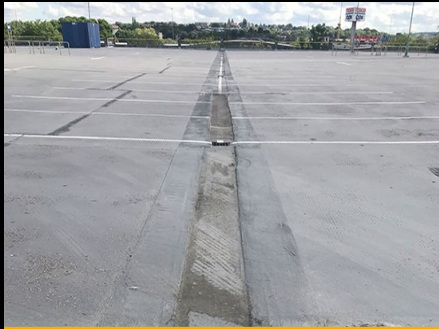
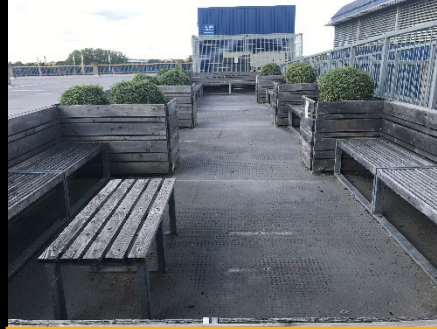
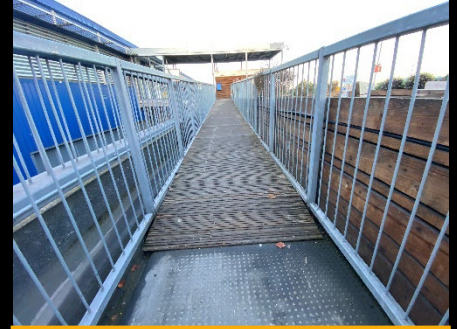
Before

The asphalt surface, although only 26 years old had considerable damage and splits in its surface. The original drainage units had become damaged and the designed gutters formed within the asphalt were allowing significant volumes of water to affect the structure and flood the immediate deck below.

The existing trolley furniture was fixing through the asphalt and into the structural topping which over time through impact had dislodged the mechanical fixings and provided a pathway for water to accumulate within the structure.

On inspecting of the asphalt substrate there were large splits and repairs within the surface. Following successful adhesion tests, the Triflex DeckFloor System was selected with their asphalt primer 222.

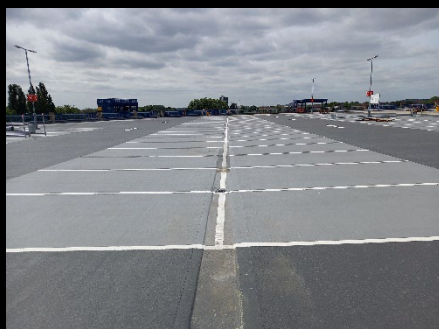
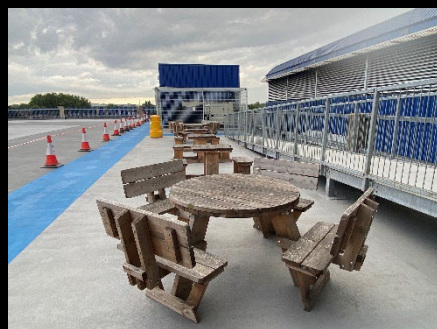
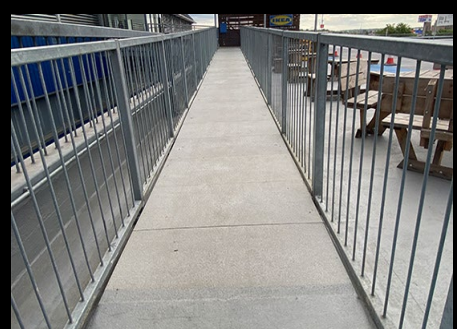
After

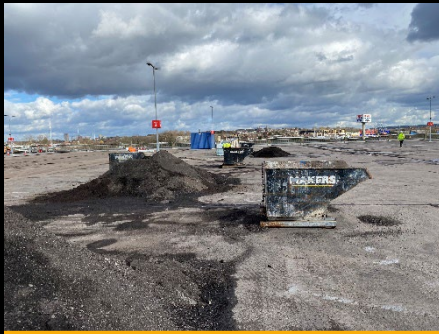
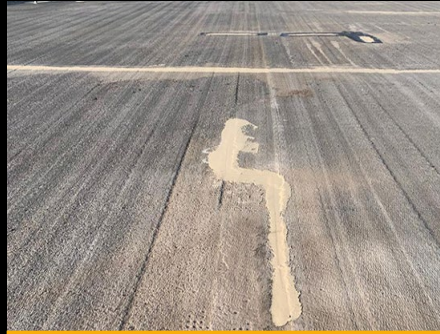
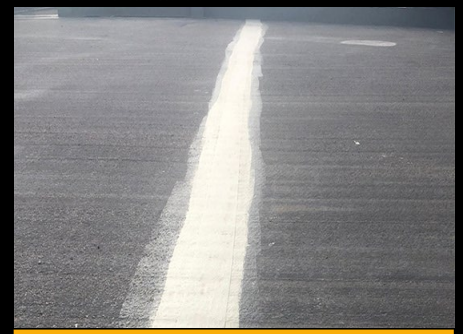
During

The main source of the water penetration was through the two main gutter runs that had been formed in the asphalt and had become brittle over time. Constant car traffic had caused the edges and arises to split away from the main body allowing large volumes of water to bypass the drainage system and make its way onto the lower levels.

The existing drain outlets were examined and cracked which were replaced together with new Harmer units that were installed to provide additional flow rate and were connected into the existing rainwater system.

The drainage gutters were reprofiled to ensure flow to the drainage outlets and their double reinforced with Triflex reinforcement to strengthen the arises and prevent separation.

Repairs were undertaken to the trolley bay areas and the asphalt removed back to the structural topping. Concrete pads were formed to the existing asphalt level and then covered in Triflex Reinforcement sandwiched between layers of Triflex ProPark. Once the remaining Triflex deck system had been applied, resin anchor fixings were drilled and the new trolley furniture installed.

The large deck area had to be planned to reduce the existing waffle profile but also removed contaminants and highlight required repair areas. Where repairs were required Triflex Degussa mortar was used to seal cracks and repairs.

All day joints and repair were reinforced where required and splits over 5mm wide were double banded for additional reinforcement.

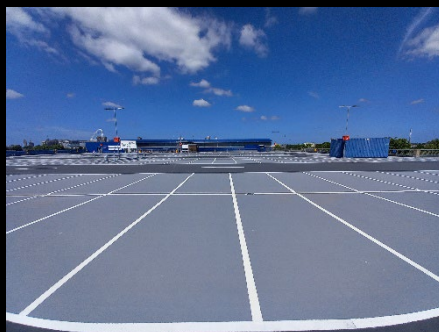
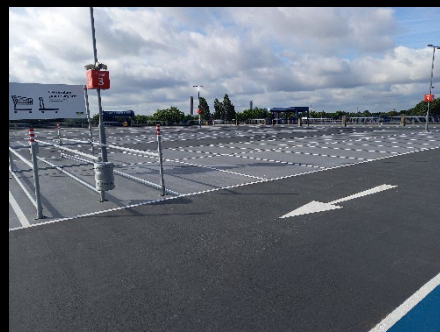
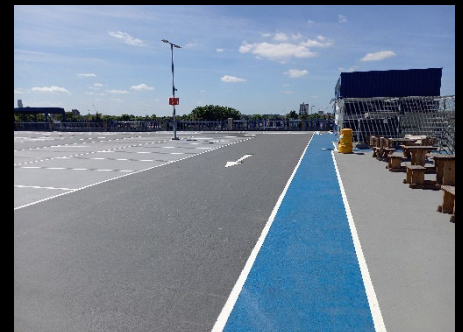
After

Once all the repairs were completed the Triflex DeckFloor system was installed with drive isles being executed in RAL 7043 and parking bays in 7037. Thermoplastic lining and directional arrows were installed back to the original design.

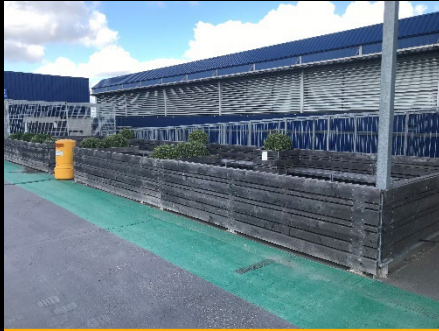
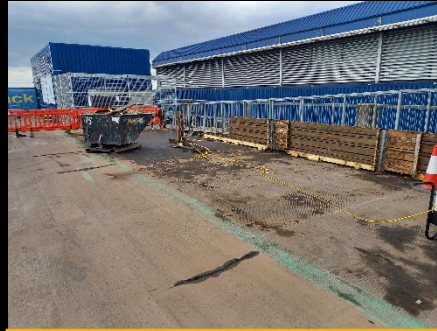
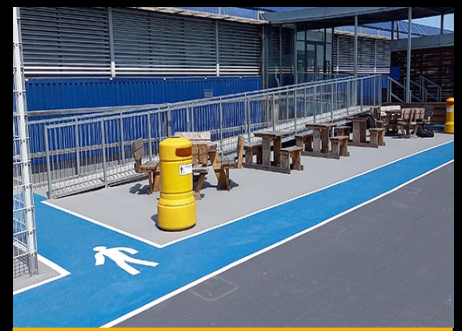
Before

During

After

The outdoor seating area and planters during the day provided an outside area for staff and members of the general public to gather but over time had become a focal point for antisocial behaviour. The seating areas was created on a number of battens drilled through the asphalt and causing numerous leaks especially with the constantly water fed planters making parking redundant on the floor directly below this area.

The client required Makers to dispose of the area and ensure the surface was watertight. During the removal process it was discovered that the lighting to the disabled ramps was contained within the planters and that the original deck slats forming the ramp were also rotten creating a risk issue.

A dedicated walkway from the lift stairwell lobby was created to direct staff to the main service office link bridge and disabled parking. The service office remained in constant use during the works and so a dedicated fenced walkway was created to welcome international visitors to the office.

The timber decking and asphalt ramp were removed together with the lighting to the ramp and the area was repaired and waterproofing and some of the original furniture repurposed and the surface areas colour coated.

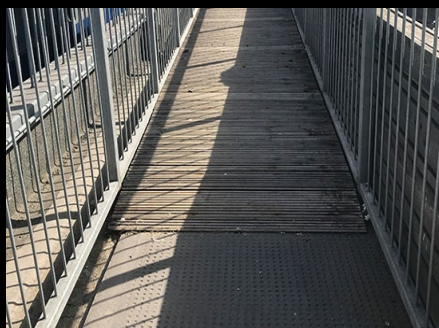
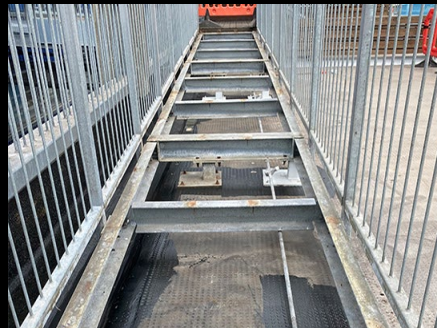
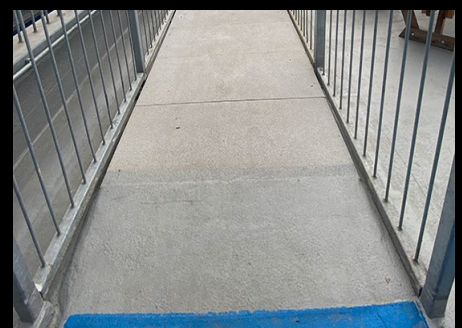
The disabled ramp posed more problems as the ramp consisted of an original galvanised metal frame to which a timber sub-frame was fitted which received the timber slats forming the ramp. As the main deck area forming the link bridge was remaining this dictated the top finish level and the existing asphalt to bottom finish level.

The removal of the timber planters also meant the removal of the electrical feed and lighting, so a new design had to be incorporated to provide a slip resistant surface that could also incorporate lights.

Before

During

After

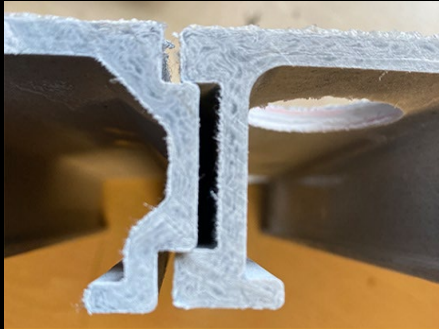
Locking

The sheeting had to be cut into a number of slats that could be accommodated on the subframe and provide an interlocking mechanism to stop them sliding. The suppliers of the GRP panels provide a 10 year guarantee for a prefinished non-slip product. The fixing required to secure the panels is usually through the top of the sheet.

The sheet consists of a number of supporting ribs beneath the surface forming chambers. We do not want the top surface to be covered in a number of fixings petering to design a secret clamping system that would secure the GRP panel to the metal subframe.

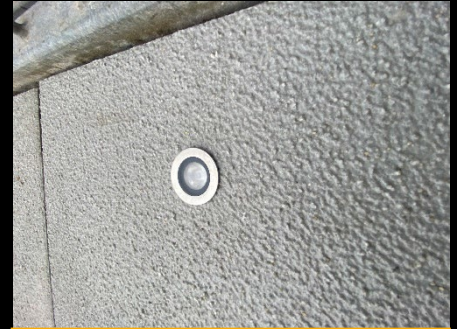
Lighting

After a number of offsite tests, we were also able to source light fittings that could be accommodated between the ribs and carefully core the GRP to ensure they could be seated correctly. The lighting is now contained within the GRP panel and a run wave effect. The bottom of the ramp was reinforced with Triflex material to make up levels and provide additional impact resistance to wheelchair users.

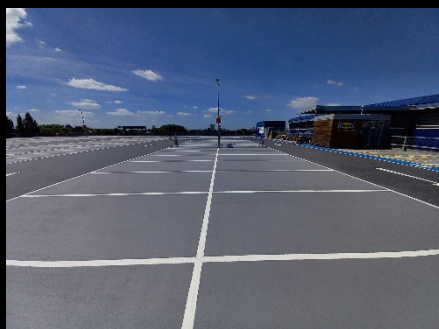
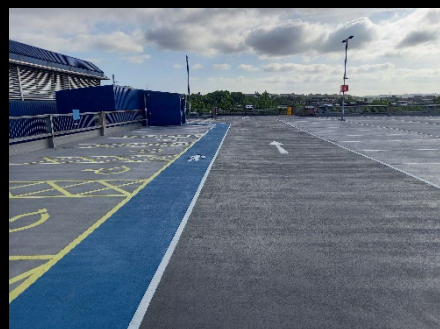
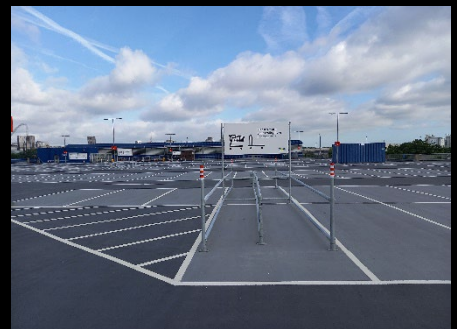
After

The area beneath the disabled ramp was waterproofed in the Triflex DeckFloor system. The project covered some 7500m2 and took 14 weeks to complete. To impact areas the system was upgraded using a greater size emery aggregate to provide anticipated additional wear.
