CASE STUDY

Car Park Refurbishment

Omni Centre MSCP

Basement Car Park

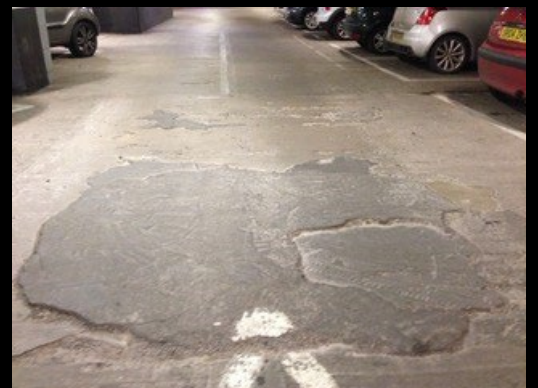
Multiple Failed Repairs

Visual inspection clearly identified a pattern of failed repairs over a number of years with evidence of anodic reactions taking place causing new repairs to fail. The number of different repair products closely placed together was a strong indication that a number of failed repairs had merely been carried out to improve the driving surface and not actually tackle the root cause of the initial repair.

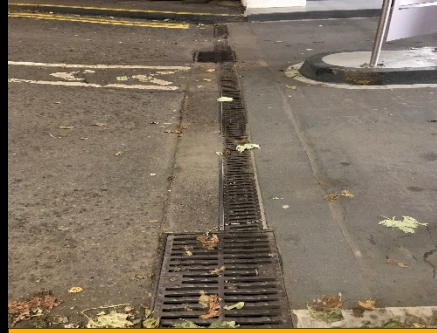
The first step was to ascertain the issues facing the car park and the underlying cause that accelerated the mode of failure. This required gathering evidence through testing, analysing the data and then devising a repair design that would overcome the issue and provide longevity to the structure. Over recent years the car park had experienced flooding due to the poor water management controls from the public highway. The steep topography of the access road meant that large water volumes could accelerate and bypass the small Acco channels located at the car park entrance. Large volumes of water passed over the channels flooding 2 of the 4 basement levels.

Entrance Acco Channel

Civil works were executed to the entrance of the car park to improve the water catchment of surface rain run-off and prevent it entering the car park. This consisted of replacing the small Acco channels and creating a big sump channel and installing an additional outlet to increase the volume of water capable of being dealt with.

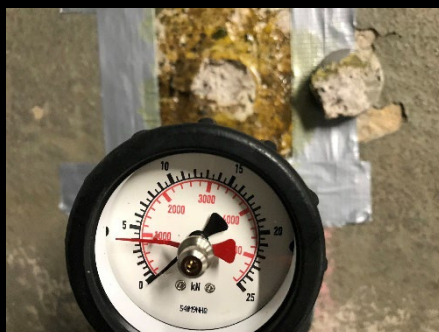
In order to design any repair systems, it is imperative that a series of tests measures be undertaken to provide a platform of data to more fully understand the behaviour of the car park and the severity of the issues and processes it is facing. Alongside the test data further, invasive information is also required to establish steel density and distribution together with concrete sampling and adhesion tests. Any system of repair will require as much data as is possible to collect together with visual and hammer surveys to measure the extent of work to be undertaken. For areas that are not exhibiting spalling or repairs a full half-cell potential survey will map those areas potentially at risk but not yet showing signs of degradation.

Adhesion test

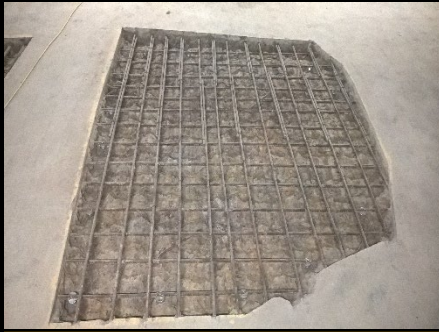
Excavated Repair

The data gathered provided a picture that meant a series of measures would need to be designed to encounter the different levels of chlorides being experienced through the car park. New repair sites would require sacrificial anodes to the perimeter of the repair sites at the required designed spacings. Areas at risk but with levels below 1% would receive MCI's, Migratory Corrosion Inhibitors, these are applied to the surface and as the name suggest migrate through the porous concrete toward the reinforcing steel creating a passive layer around the steel. The ability to migrate to the steel again depends on the matrix of the concrete and density of the steel. To areas of high risk and suffering high chloride levels a fully designed ICCP (Impressed Current Corrosion Protection) system would be needed.

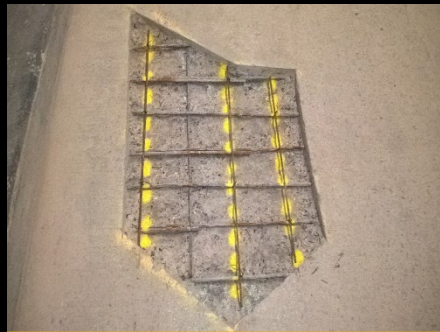
Replacement Reinforcement

The anode requires to be powered at all times with a direct current supply to create the battery cell of cathode and anode to allow for the exchange of electrons and chloride ions. This also requires the reinforcement to be continuous and adequate and any missing or damaged steel was replaced in Omni case some 1200m. The car park consisted of over 32,000m² of surface area and the amount of ICCP was dictated by the half-cell potential survey. Just over 11,000m² of the deck surface was required to be treated by the ICCP design which would involve over 27,000m of chasing and titanium wire so prior to the full-scale installation a preliminary study was undertaken to assess the performance of the design to establish that it could be installed and that it would deal with the issues.

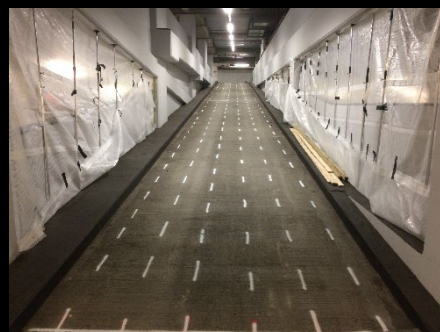
Channels for Titanium Wires

In order for system to protect the steel the system has to be powered at all times, for it to be managed it requires measurement probes to be installed within zones and that the created anode has the power or "throw" to deal with the volume of steel it has to protect. The siting of the anode is critical, too far away and it won't protect the steel, too close and there is a risk that the anode will come into contact with the steel creating a short in the circuit. The system is based on the introduction of an acid resistant coated titanium wire measuring 0.79mm in diameter and embedded in a chase measuring 10mm wide 20mm deep and infilled with a specially designed conductive mortar. The conductive mortar is critical to the creation of the anode.

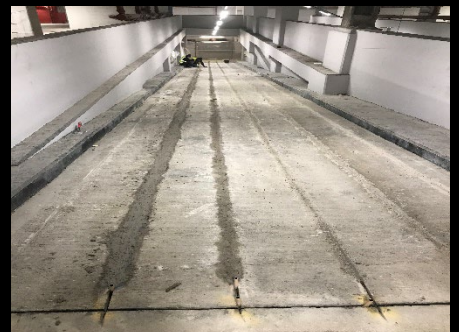
Conductive Mortar Anode

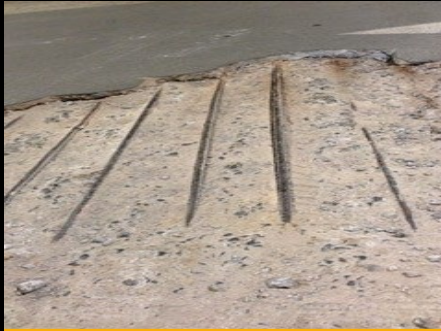
Exposed Surface Steel

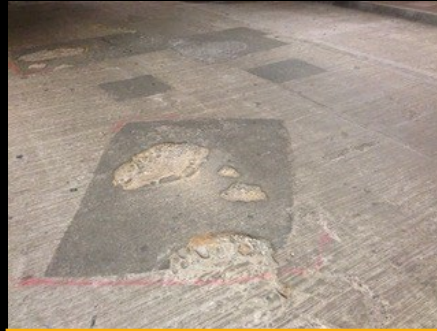
Anodic Reaction

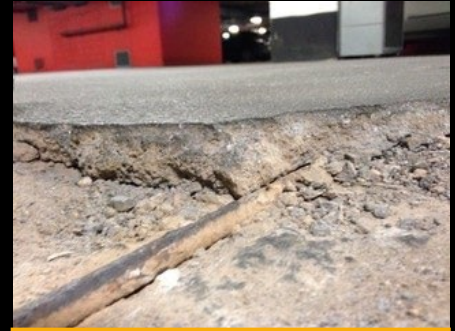
Debonded Concrete

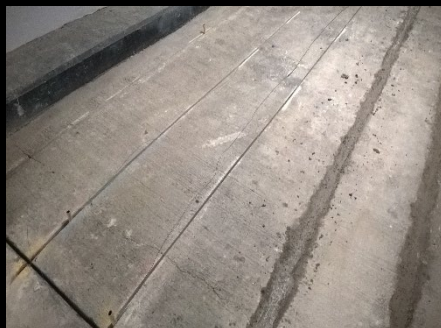
ICCP Runs

ICCP systems are fully powered systems and to be successful require a fully powered direct electric supply, continuity of the reinforcement within the concrete structure and the installation of an anode system that can be installed close to influence the affected steel. The logic behind the system is that it works on the basis of ion exchange by encouraging chloride ions to migrate towards the anode whilst at the same time exporting electrons to the reinforcement so that over time the layer around the steel becomes more passivated. As the chloride ions become more diluted as the system works the system can over time be turned down or managed to meet the corrosion rate potentials.

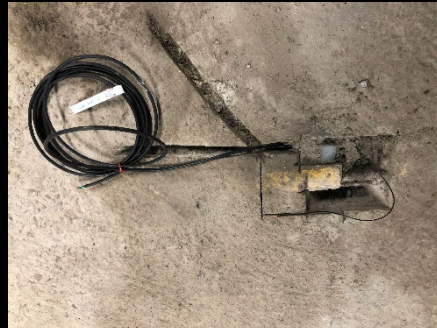
Monitoring Probes

The system is a managed system and as such has the capability of being monitored remotely requiring the areas to be broken down into effective zones 34 in total. Each zone contains reference probes which constantly monitor the zones and these reference probes were extended to monitor the 15,000m² of car park surface treated by MCI's.

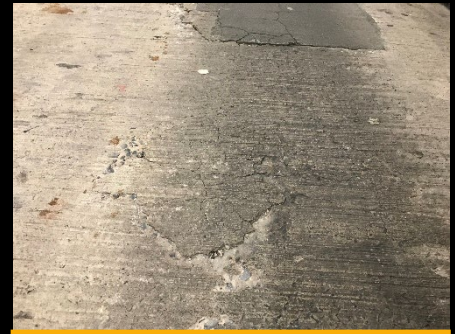
Surface Profile

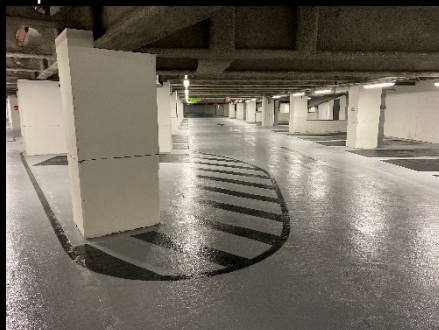
Triflex Epoxy System

A two coat Triflex epoxy filled system was installed after the installation of repairs and corrosion measures. This was selected given the lack of air movement experienced at the lower basement levels. The system colours were adopted to meet the current Q-Park brand and their bay and demarcation preferences installed to match their car park branding.

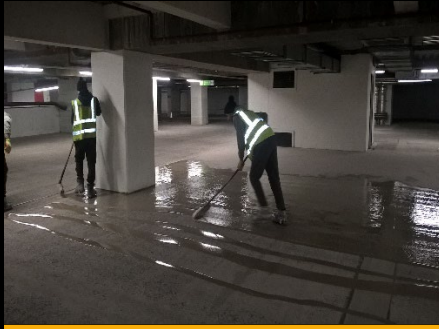
Base Layer Application

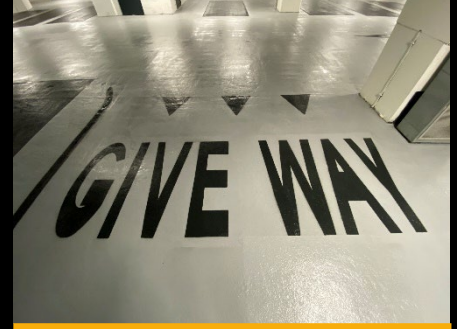
Seal Coat

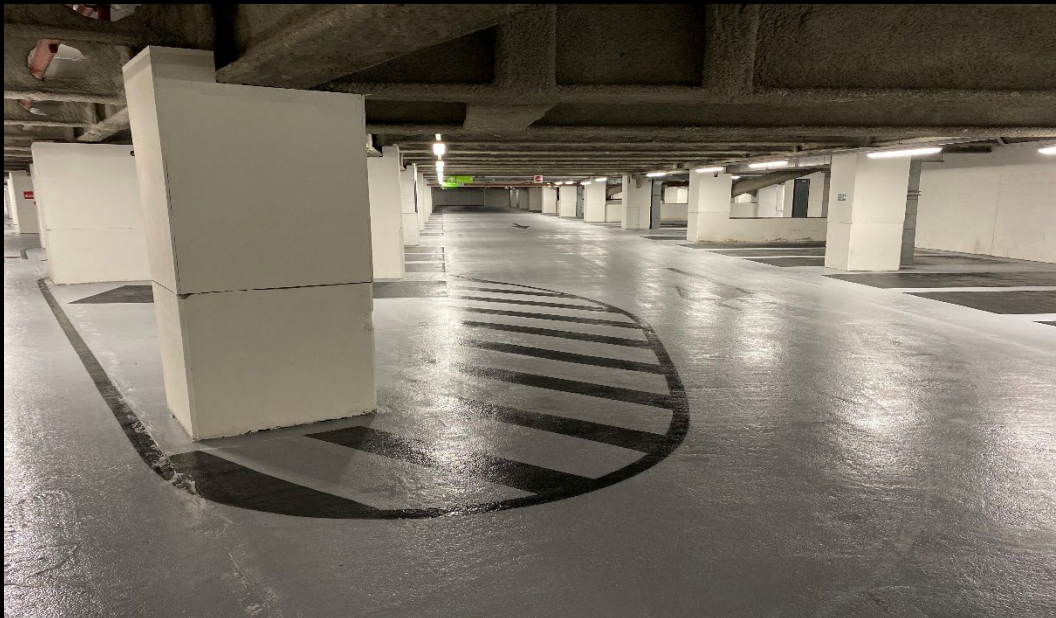
Fully Installed System
