CASE STUDY

Car Park Refurbishment

Birmingham Airport

Car Park MSCP 1

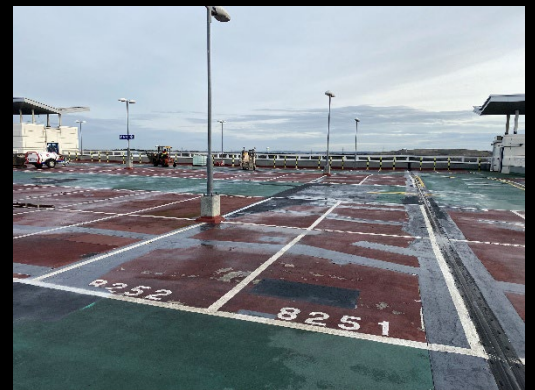
Over time, the structure including the top two open decks began to exhibit signs of wear and deterioration, resulting in water ingress to the lower decks. The previous coating detail had undergone several repair attempts, but with progressive debonding it was risking damage to the concrete beams below.

Before

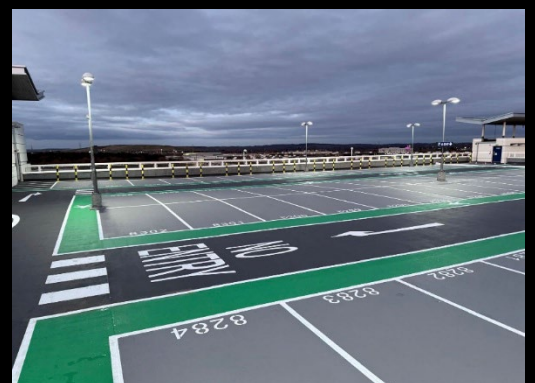
After

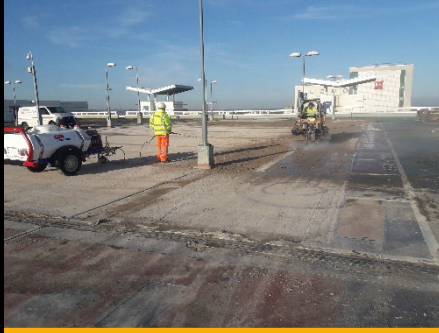
Removing existing coatings

The initial stage of the works involved the removal of the existing deck coatings. This was undertaken using a three-stage mechanical preparation process & hand preparation. First, the coatings were planed off to remove the bulk material. This was followed by a Shabekei preparation process, and finally a heavy captive blast clean to achieve the required surface profile.

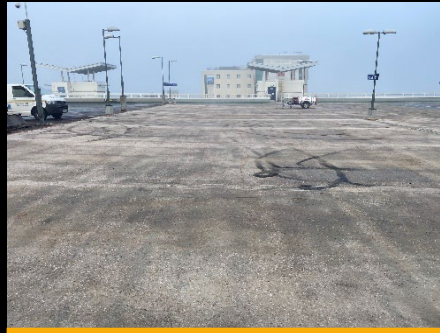
Ready for concrete repair

Following preparation, the concrete substrate was thoroughly surveyed for defects. Any identified areas of deterioration were cut out and repaired using an appropriate structural repair mortar. In addition, pull off tests were conducted to determine the cohesive strength of the substrate. This testing verified that the concrete was sound, free from weak surface laitance and capable of achieving the bond strength required to prevent premature coating failure, such as delamination. Ensuring adequate substrate integrity is critical to the long-term durability and performance of the new system.

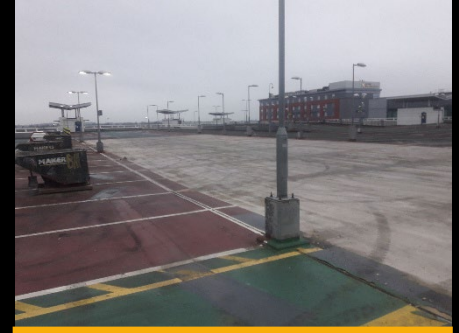
Area ready for captive blast

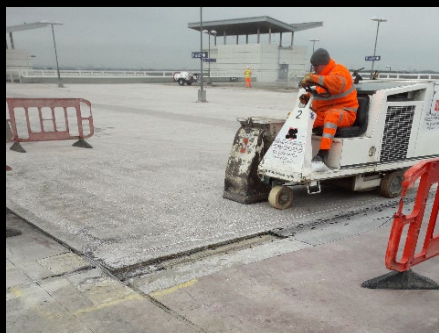
Captive blast being carried out

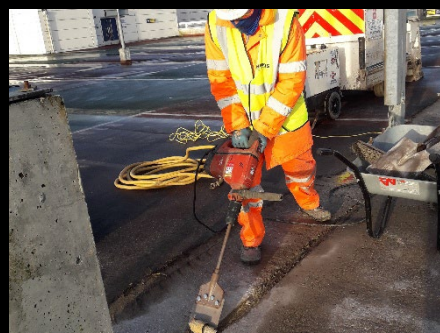
Edge preparation ongoing

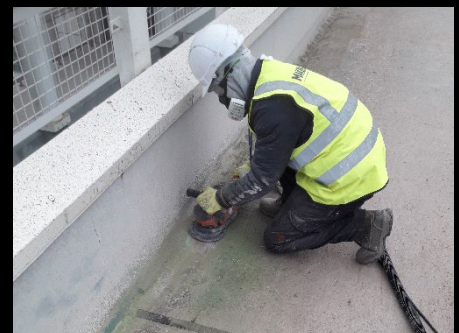
Edge preparation to

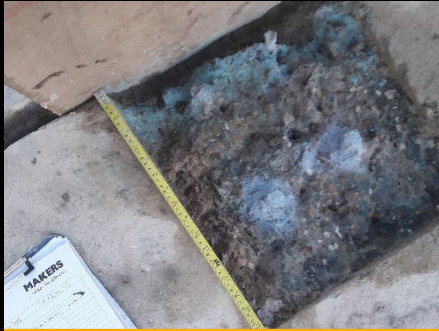
Concrete repair broken out

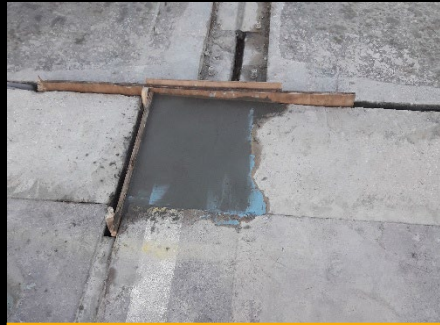
Concrete repair reinstated

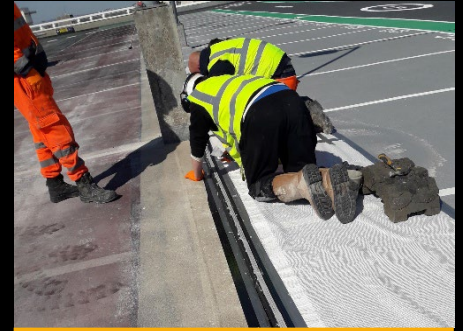
Installing the new expansion joint

As part of the wider remediation works, we were also required to replace the failed expansion joint. Following a technical review of several alternative systems, the client selected a Wabo expansion joint to accommodate the structural movement within the deck. The scope involved the removal of the existing joint, comprehensive preparation of the arises and joint interface, and the installation of the new system using a structural adhesive.

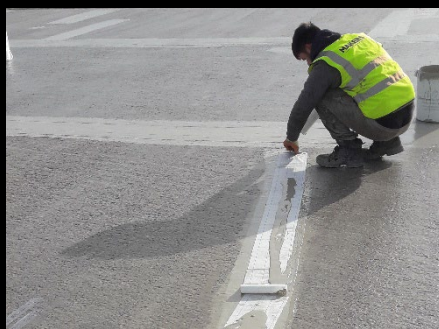
Reinforcement banding

This was followed by the installation of reinforcement banding to all day joints and identified cracks, providing additional protection to areas subject to movement and stress. A full reinforcement fleece was then applied across the entire deck surface, forming the core of the waterproofing system and ensuring a fully bonded, monolithic membrane.

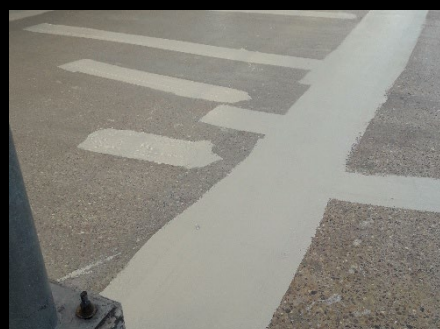
Reinforcement banding complete

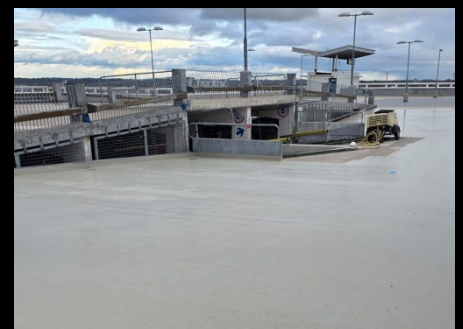
Area fully reinforced

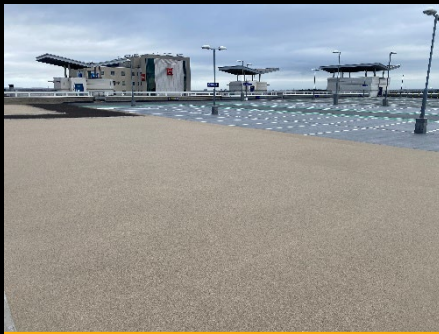
Wearing layer applied

Finally, the DeckFloor coating was applied and blinded with quartz sand to create a durable, slip-resistant finish suitable for general trafficking areas. Ramps and drive lanes particularly at turning points were upgraded using a 1-3mm emery quartz to assist with durability and winter operations. Emery provides a more robust and abrasion-resistant finish, capable of withstanding the increased stresses associated with frequent vehicle manoeuvring and concentrated traffic loads. Finally, the Triflex system was sealed with a coloured topcoat, with the specific colours selected by the client. Upon completion of the coating works, the entire deck was re-line marked in accordance with the client's design, using a combination of spray-applied Preco system to deliver clear, durable, and high-visibility markings as well as a more durable hand applied cold plastic system for more trafficked areas such as arrows.

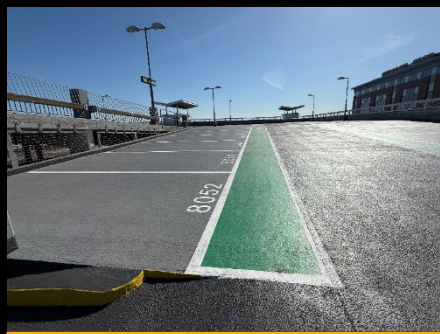
Emery Quartz to drive lanes

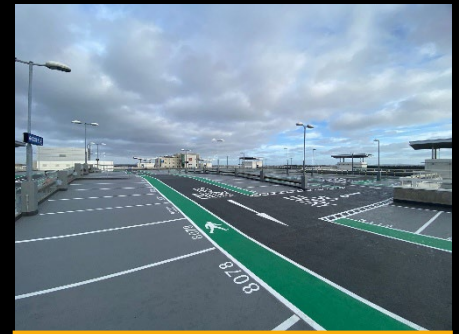
Works complete

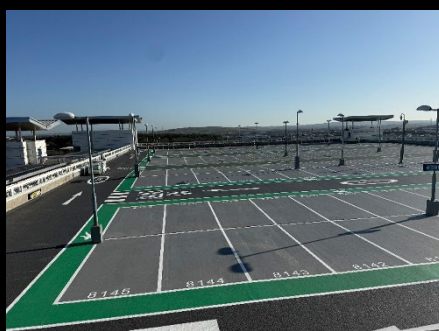
Works complete to phase 1 & 2

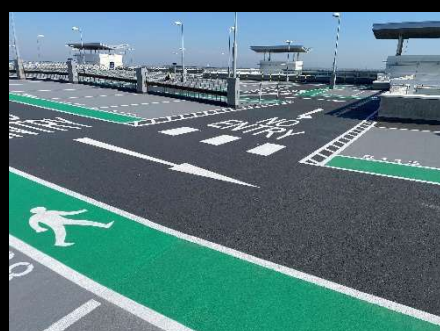
Works complete

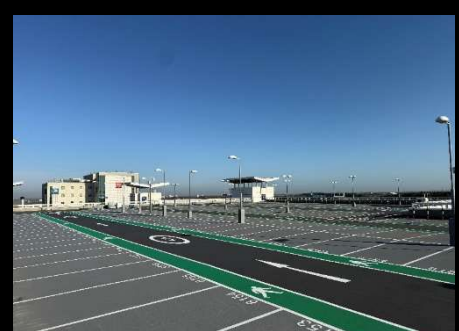
Works complete

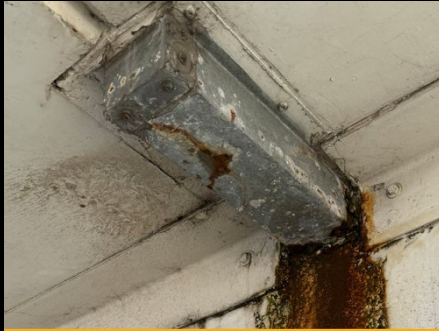
Corroded existing guttering

After reviewing the existing slot drains it became apparent that cleaning or maintaining the outlets during normal operations was challenging and the system was removed to investigate. Upon further inspection, the capacity of the drainage gutter had been reduced in some areas due to blockages and was compromising the capacity of the system.

Makers designed a gutter from folded galvanised steel that allow joined sections to pass through existing column openings. Waterproofing was then applied to the inside of the sections to provide longevity and shut off valves were introduced above the down pipes to ensure that no material could travel down the main stack during cleaning. A central drainage point was also added to flush debris out of the gutter and into a portable filter system which could then be disposed of. The gutter was designed in sections so it can be dismantled, replaced or moved if required.

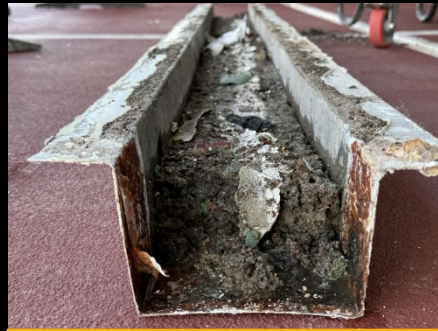
80% of capacity lost due to debris

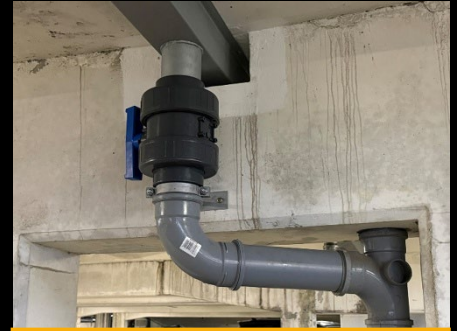
New shut off valve installed

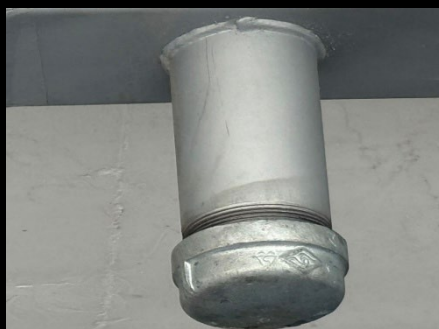
Central drainage point

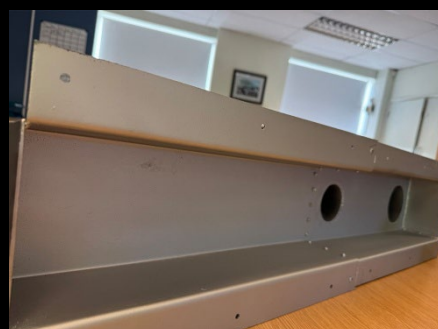
Galvanised section ready to install

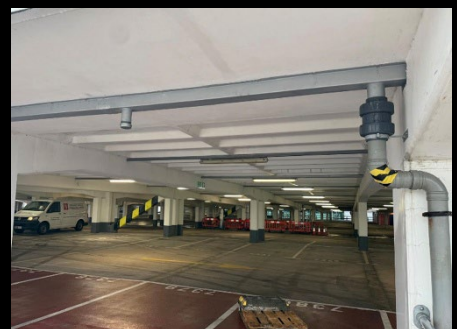
New completed gutter installed
