Resurrecting Allhallows

A car park in Bedford was spared the wrecking ball to become a gateway

A 1960s multi-storey in the centre of Bedford has been completely refurbished as part of the new gateway to the town centre. The Allhallows car park was fully reopened to the public over the Easter weekend in April this year following a 52 week programme. It has been revamped by Makers Construction for Bedford Borough Council.

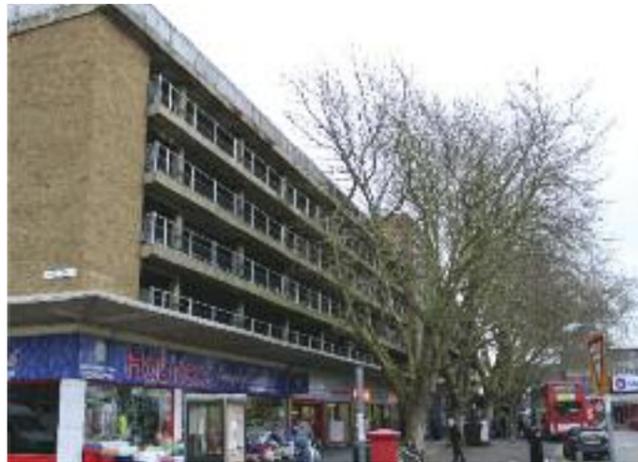
Allhallows' original exterior

One of the most conspicuous changes is the façade. "The brickwork elements of the exterior have been repaired and enhanced receiving a three-coat render to give it a more modern look," says Middleto. "Work on the external façade was carried out from scaffolding to access edge slab repairs and install windows. New & specially

designed multi-coloured aluminium aerofoil fins have been installed to create a more attractive façade, fixed via a secondary framing system following the completion of structural repairs."

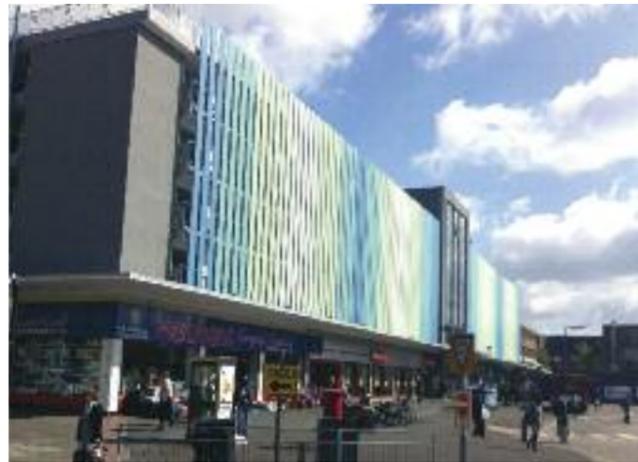
Allhallows' new look façade

At night LED uplighters create colour washes on the façade.

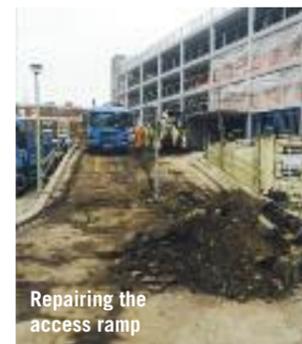
Repairing the access ramp

The car park's original vehicle entrance was cluttered and failed surfacing allowed water penetration into the concrete structure below. "The existing surface of the entrance ramp was planed off and the exposed concrete re-waterproofed with a spray-applied waterproofing membrane and resurfaced in tarmac by Bedford council's highways contractors. Entry and exit signage has been simplified to provide fewer distractions."

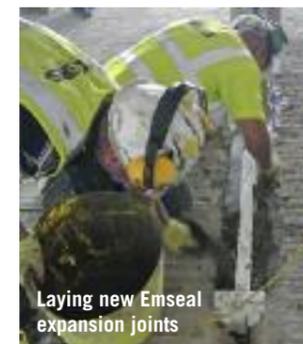
Laying new Emseal expansion joints

The car park's expansion joints were also replaced. "Joints fail for many reasons and are the most vulnerable part of a structure," he says. The failed joints were replaced with US-manufactured Emseal DSM joints, for which Makers are the sole approved UK installer. "The DSM joint is held in place using a structural adhesive followed by the application of the decking system to provide continuity of the waterproof system," he says.

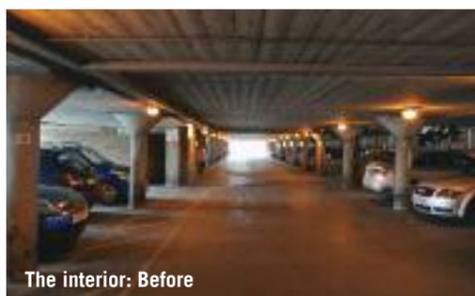
The interior: Before

Inside, extensive concrete repairs were undertaken to the decks and soffits throughout. This work started with testing and identifying defects using Electro Magnetic Anomaly Detection (EMAD), which revealed areas where steel reinforcement continuity and structural integrity had been lost. Detected anomalies were then investigated further to identify causes of the problems.

Hydrodemolition was used to remove the defective concrete from areas of deck and soffit. "The 'hydrodem' process simultaneously removes concrete and cleans the steel reinforcement," says Middleton.

On the soffits, where required, new 6mm steel reinforcement bars (rebar) had to be installed. The repaired areas were spray-applied with the Sikacem 133 system and the soffits trowelled off but one of the challenges was to retain the 'board mark' shuttering to help the repairs blend in with the non-repaired areas. The repaired soffits and

walls were next coated with the Sikagard 675w anti-carbonation coating. In the decks adjacent to the bases of the columns, much of the steel reinforcement had to be exposed followed by repairs.

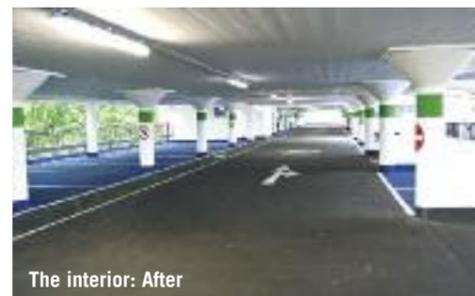
The interior: After

"The decks were prepared with captive blasting prior to the installation of the Sikafloor 161 decking system for intermediate decks. Driving aisles were marked in dark grey and parking bays in dark blue, while white lines were used to mark out parking bays and walkways"

Middleton says: "Each floor is now numbered and colour-banded with corresponding colour-coordinated doors in each stairwell to help with floor location. Allhallows had originally operated as two separate car parks, which meant it used to have two circulation paths. The circulation has now
