Merrion remade

The 1960s Merrion Centre car park in Leeds is being transformed into a 21st century car park, reports **Mark Moran**

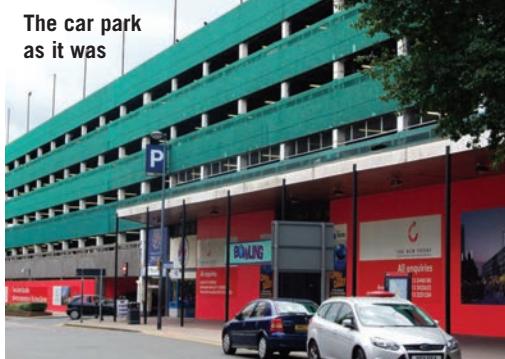
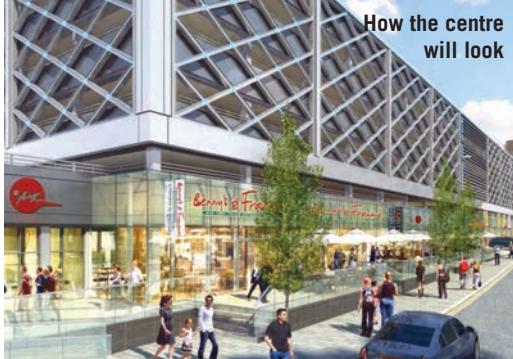
Recoating the top deck

Sika's Mark Bushell says the top deck was treated with SikaFloor Pronto decking system, which has a fast application that minimises the time a deck is out of action. "Featuring PMMA (polymethyl methacrylic), the resin flooring system is ready for foot traffic after one hour and fully cured after two," he says.

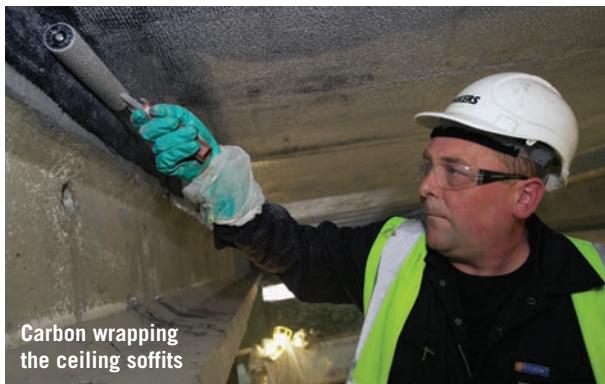
Carbon wrapping the ceiling soffits

The approach adopted at the Merrion Centre has been to strengthen the decks using carbon fibre wrap with anchors installed every 300mm. The anchors are a cluster of carbon fibre ropes, which spread the load. They are inserted into holes drilled into the beams and then fanned out over the carbon fibre sheets. A total of 37,000 anchor holes will be drilled.

Sika proposed the use of a carbon fibre structural strengthening system using SikaWrap Anchors and the high performance SikaWrap 300, a reinforced carbon fibre fabric which was used for the flexural and shear strengthening of slabs within the building structure.
