CASE STUDY

Car Park Refurbishment

Walkden St MSCP

Multi-storey Car Park

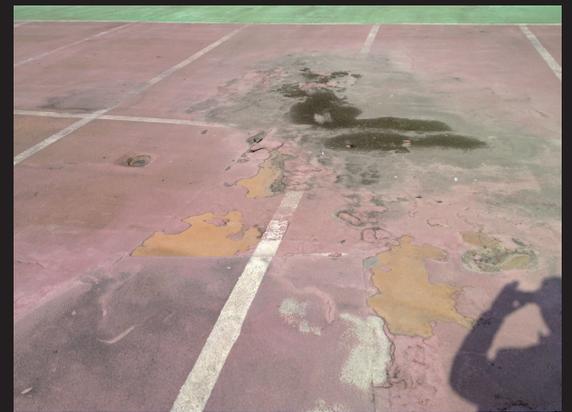
The reinforced concrete top deck had a waterproof membrane that had been applied some years earlier but which had degraded and failed in many areas allowing the ingress of de-icing salts – carried into the car park by vehicles – through the original daywork and failed movement joints in the concrete deck. The consequence was a significant volume of spalling and corrosion damage to the concrete soffits. This resulted in the top deck being closed to vehicles in 2012 for safety reasons.

Before

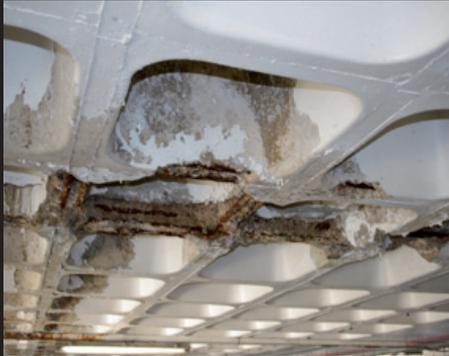
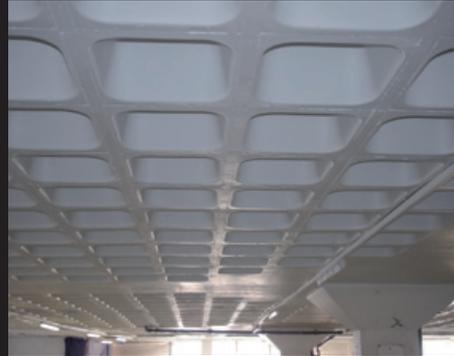
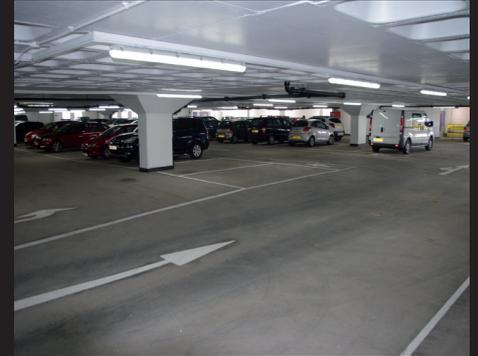
As a consequence of the failure of the original top-deck waterproofing membrane, there had been significant water ingress into the decks below through the original daywork construction joints. The reinforced concrete on the corresponding soffits below was demonstrating a range of defects as a result of salt chlorides getting in to the substrate. Prior to the works commencing, a detailed hammer survey was carried out which identified a significant volume of delaminated concrete as a result of reinforcement corrosion.

Following removal of the defective concrete and thorough preparation of the exposed reinforcing bars, a full programme of concrete repairs were carried out using the Sika Monotop system with some 5m³ having to be reinstated. A migratory corrosion inhibitor was also applied along the daywork joint lines for added protection.
