# STRUCTURES CASE STUDY

Eastgate MSCP, Basildon

Car Park

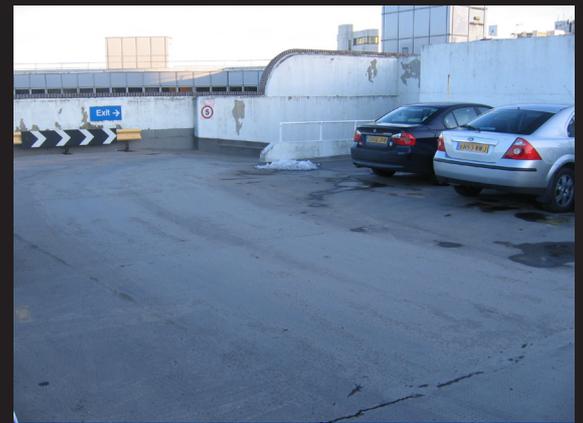
With little maintenance carried out since its original construction, the centre's reinforced concrete, flat-slab multi-story car park – with 800 spaces – was displaying a variety of defects throughout the structure.

The top deck asphalt waterproof layer had failed and was allowing salt-water ingress to the structure below as well as the asphalt on levels 1 & 2 internally.

Before

This seven-storey car park underwent a 48-week programme of full internal refurbishment which required approximately 40m<sup>3</sup> of concrete repairs to decks, soffits, columns & beams.

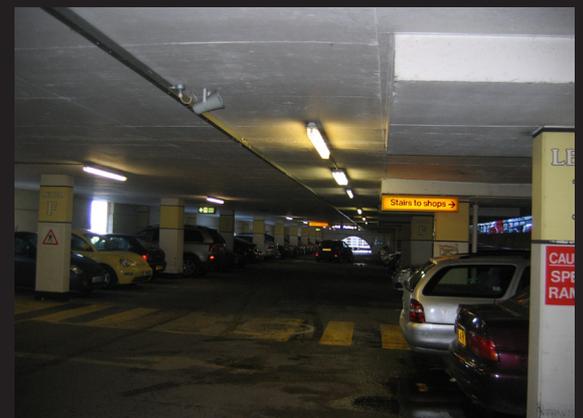
Before

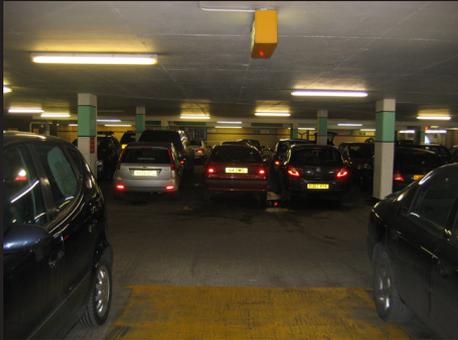
Owing to its 1980's design, the reinforced concrete column spacings throughout the structure provided three parking spaces sandwiched between the columns. The narrow width of each space meant that customers of the centre's car park found it difficult to use getting in & out of parking spaces.

3 Narrow Spaces between Columns

As well as providing a new lighting scheme throughout with new signage, Makers recommended that given previous poor utilisation issues combined with narrow parking spaces, the spaces between the columns was reduced to two parking spaces from three. Though the overall number of spaces has been reduced from 800 to 700 spaces approximately, the shopping centre's owners have seen a dramatic uplift in utilisation resulting in improved revenues.

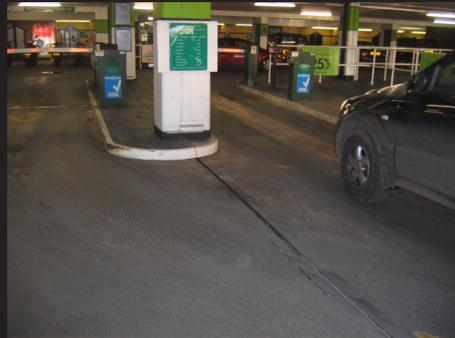
Original Entrance / Exit

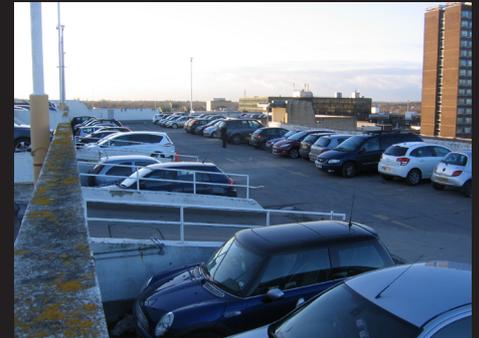
Original Roof Deck

In order to revive and protect the internal aspects and structure of the car park, a combination of Triflex and Sika's non slip waterproof deck coatings were installed to the intermediate parking deck surfaces using contrasting colours for drive aisles and parking bays. The parking decks were a mixture of asphalt and reinforced concrete substrates.

Following careful preparation of both concrete and asphalt surfaces, concrete repairs were required to the concrete decks followed by the application of Sika Ferroguard 903 migratory corrosion inhibitor as a corrosion management system. Both the asphalt and concrete deck surfaces throughout were primed in readiness to receive the colour deck coatings. All cracks and daywork joints were overbanded with a fibre mesh to provide further crack-bridging and to ensure a seamless application of the waterproof and protective deck coatings. Anti-carbonation coatings were applied to the soffits, columns and beams throughout to further brighten the internal appearance and enhance the customer experience with a light & bright car park.

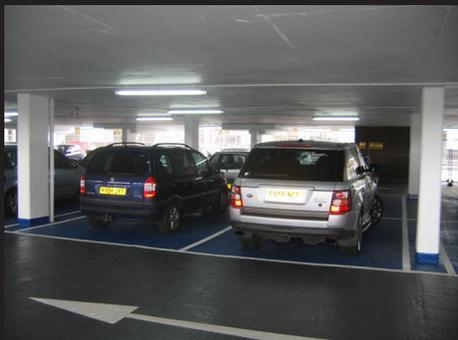
2 Wider Spaces between Columns

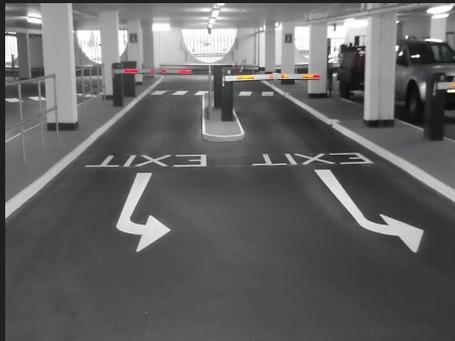
Revised Entrance / Exit

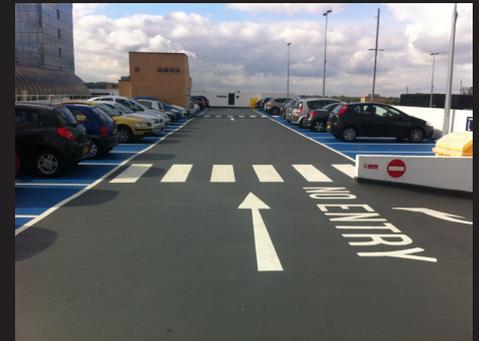
Top Deck After
