Steel Footbridge Refurbishment

Weston Favell Shopping Centre
Standens Barn Bridge

Structural Refurbishment

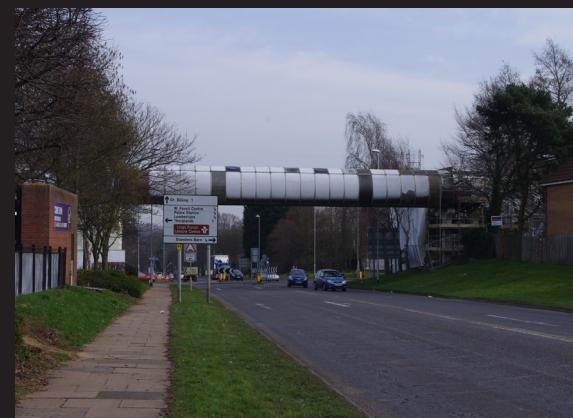
Before

This steel footbridge structure – built in 1975 - had been neglected for many years along with its concrete and steel supports, and had not received any meaningful maintenance work since its original construction. Its refurbishment was the first major part of a larger scheme of repairs & refurbishment to the overall shopping centre carried out by Makers Construction.

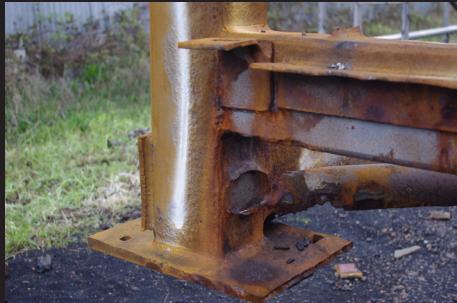
Corroded structural members

Following a full structural appraisal, several bridge sections were structurally deficient requiring a series of repairs to structural members which in some cases were so badly corroded that they required complete renewal.

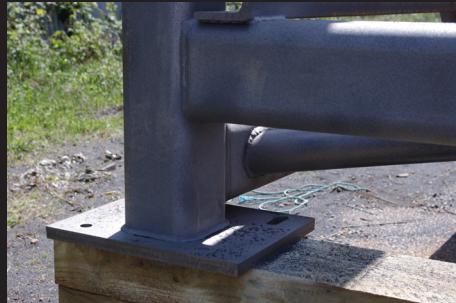
Defective steelwork replaced

Once off site, each of the bridge sections were grit-blasted to remove all existing paintwork back to bare metal, followed by the structural repairs to the required sections. The bridges were then re-blasted to remove flash-rusting and immediately painted with a spray-applied, three-coat protective paint system.

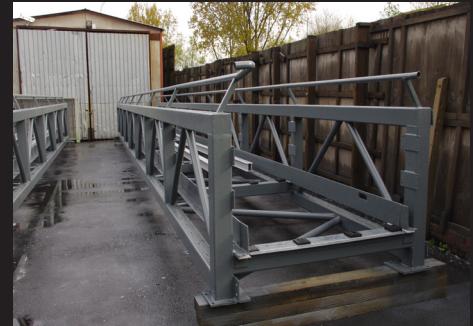
Sections stripped & repainted

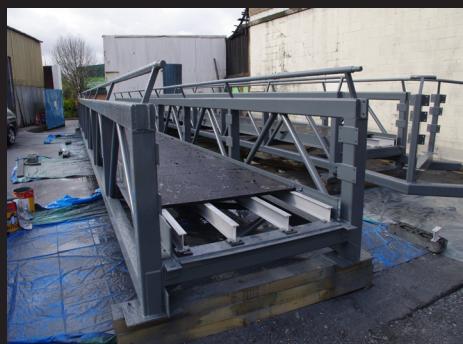
Composite decking installed

The original steel decks to the walkways were so badly corroded; they were completely removed and replaced with a composite decking material supported on composite beams. In using this approach, the new decking and supports will not corrode providing a life to first maintenance period of 50 years. The original enclosed steel & perspex roof of the footbridge across the dual carriageway was also removed and replaced with a more user-friendly and aesthetically acceptable open steel mesh enclosure with new signage and wayfinding added.

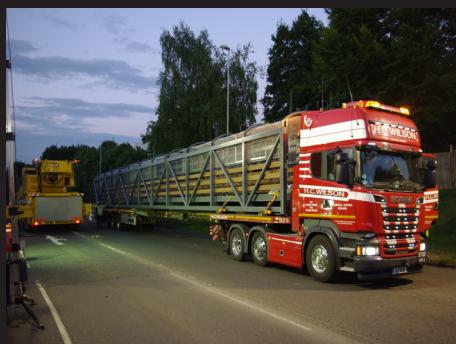
Refurbished & returned to site

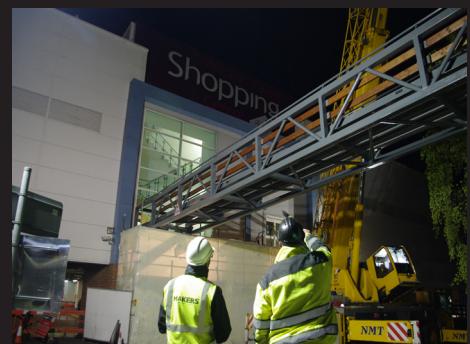
Re-positioned overnight

The original plan was to refurbish the footbridges in-situ, however, given a series of both practical AND safety concerns, Makers proposed to remove the footbridges in their entirety in a series of overnight crane lifts requiring road closures and traffic management to minimise disruption.
