Making a multi-storey smart again

Makers Construction revamps Mansfield's Walkden multi-storey

Mansfield District Council's Walkden multi-storey car park has been refurbished at a cost of £477,000.

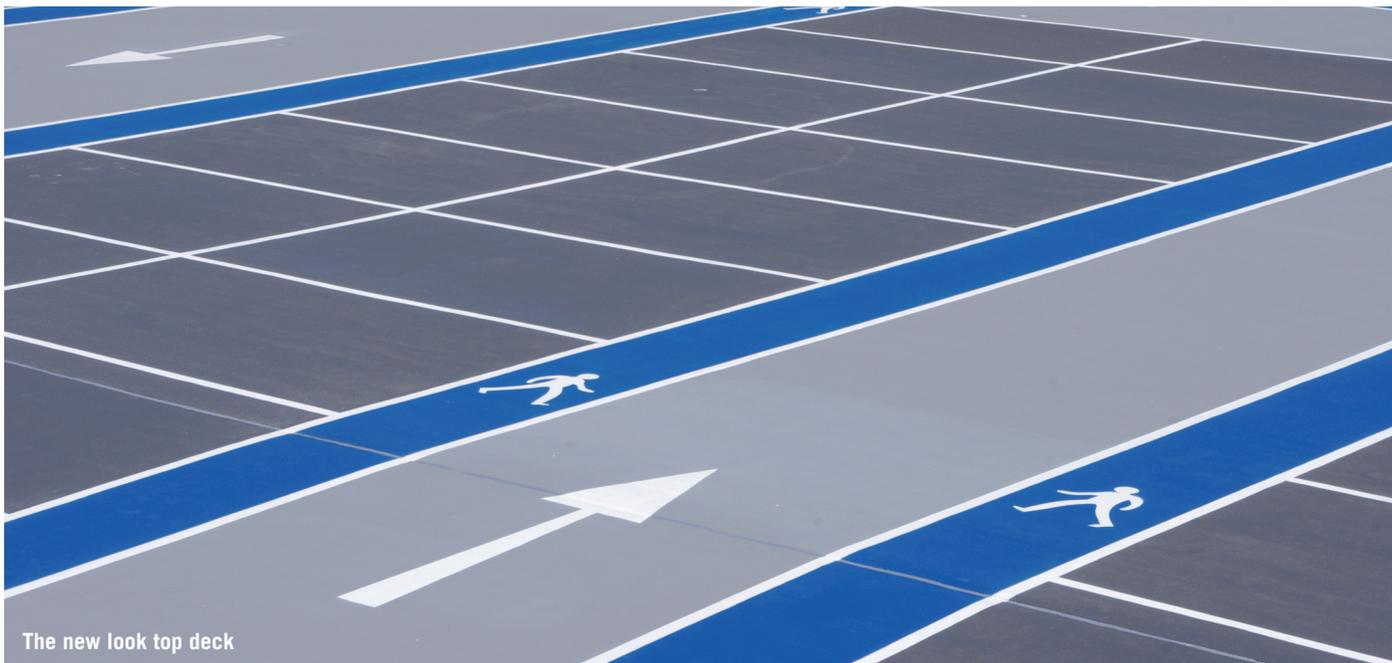
The new look top deck

"The top deck was completely re-waterproofed with the fully-fleeced Sika Pronto deck waterproofing system to ensure that the previously leaking daywork joints could not fail again. The system was applied to some 4,600m² of deck area including the up and down access ramps between the upper decks.

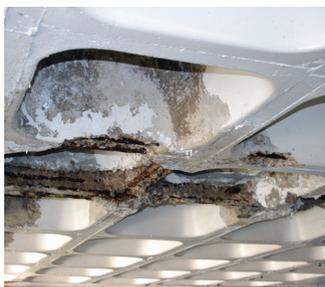
The consequence of this was a significant volume of spalling and corrosion damage to the concrete soffits. This resulted in the top deck being closed to vehicles in 2012 for safety reasons.

"The reinforced concrete on the corresponding soffits below was demonstrating a range of defects as a result of salt chlorides getting in to the substrate. Prior to the works commencing, a detailed hammer survey was carried out which identified a significant volume of delaminated concrete as a result of reinforcement corrosion.

Soffits: Before

"Following removal of the defective concrete and thorough preparation of the exposed reinforcing bars, a full programme of concrete repairs were carried out using the Sika Monotop system with some 5m³ having to be reinstated. A migratory corrosion inhibitor was also applied along the daywork joint

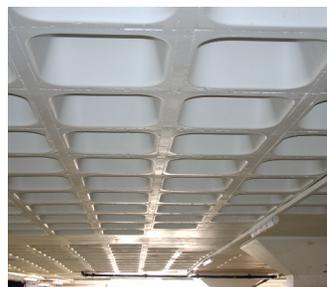
Soffits: After

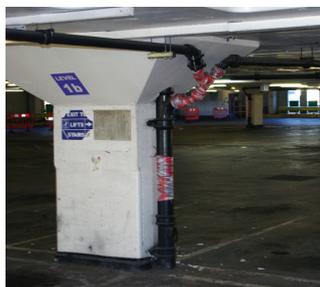
Pillars: Before

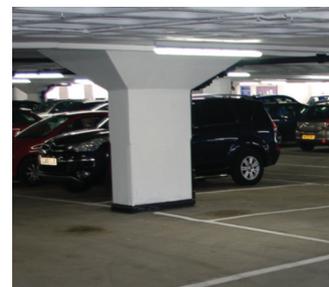
Pillars: After
