Highly Flexible Waterproofing To Failed Asphalt Decks

High Chelmer MSCP
Chelmsford

MSCP

Chelmsford City Council

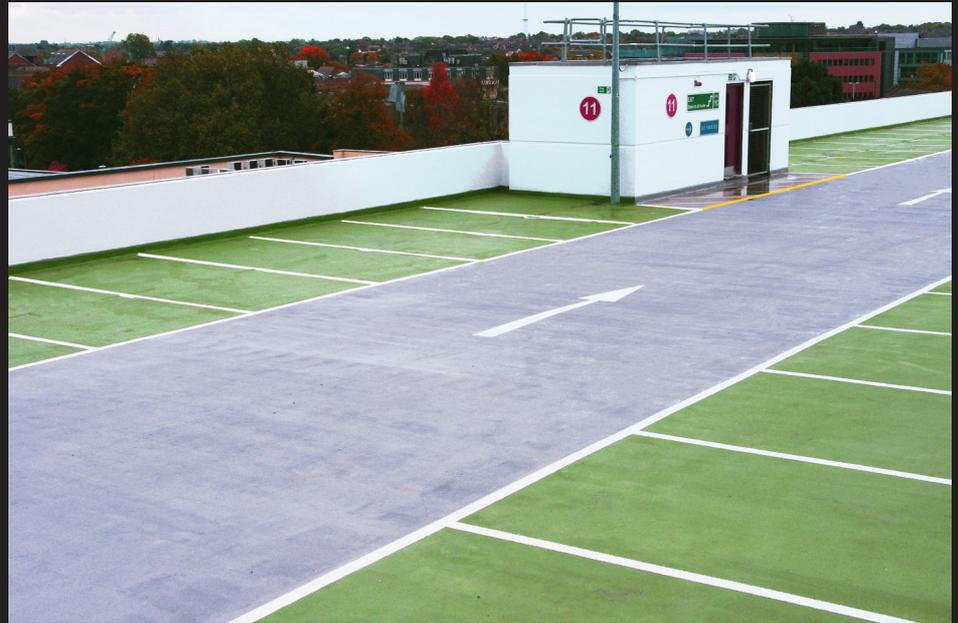
Owned by Chelmsford City Council and located adjacent to Chelmsford's High Chelmer Shopping Centre, this reinforced concrete multi-storey car park provides in excess of 1,000 parking spaces. Having undergone a major programme of refurbishment to the internal elements of the structure some four years ago, it was now the turn of the top deck to be completely re-waterproofed.

The top deck – split over three levels – had been waterproofed with a mastic asphalt wearing surface since its original construction in the 1960's however given long-term exposure to the elements combined with constant vehicular traffic, the asphalt layer had developed many splits and cracks allowing water to enter into the car parking decks underneath.

Makers were awarded a 14-week contract by Witham-based Principal Designer & Project Manager J P Chick & Partners, to fully re-waterproof the top decks of the car park including alterations and additions to the existing drainage system, washing down and painting the reinforced concrete parapet walls (including the application of a migratory corrosion inhibitor) and the replacement of failed movement joints.

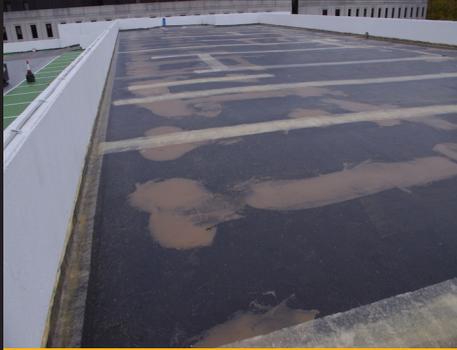
Banding to cracks / day joints

In order to ensure complete watertightness around the perimeter of the gullies at the junction with the existing asphalt, Sika's fibre reinforcement mesh was dressed down into the gulley mouths. With the repaired cracks in the asphalt also overbanded locally with mesh to ensure full crack-bridging performance, the Sika deck waterproofing system was applied to all three top decks; an area of 5,400m² in total.

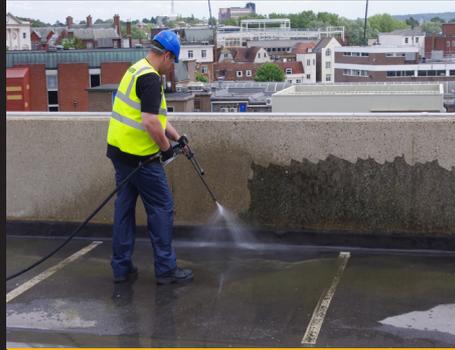
Cleaning parapet walls

The reinforced concrete parapet walls were powerwashed to remove existing dirt and surface laitance and Sika's migratory corrosion inhibitor – Ferrogard 903 – was applied for additional corrosion protection. A Sikagard anti-carbonation & protective coating was also applied. Failed mechanical movement joints were removed and replaced with Emseal's 50mm wide DSM joint system.

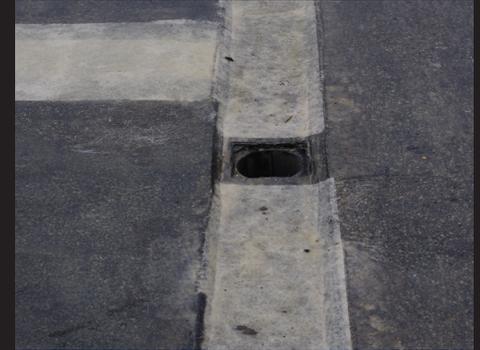
Pre-filling

The surface of the existing asphalt deck was first prepared by captive grit-blasting onto which Sika's RB28A car park decking system (specifically designed to be applied to asphalt surface) could be applied. All existing line markings were also removed by planing. To enhance the drainage of the car park, 38 no. 200mm holes were cored through the top decks at various locations into which new drainage gullies and traps were installed and connected to the existing drainage system.

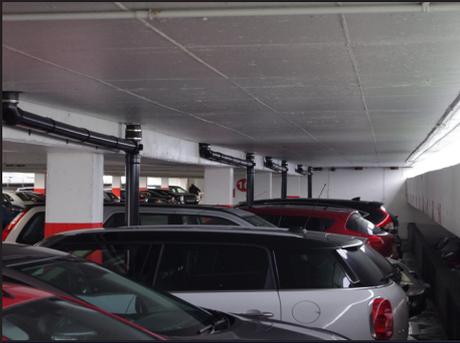
A long-term issue with the top deck had been excessive ponding of surface rainwater as a result of inadequate and poor original drainage detailing. Apart from there being insufficient drainage gullies, the drains were set too high - preventing the rainwater falling towards the drains. The drains were also blocked as a result of a lack of maintenance. In the areas where rainwater was ponding, the cracks & splits in the asphalt surface was allowing water into the structure below.

Additional Drainage

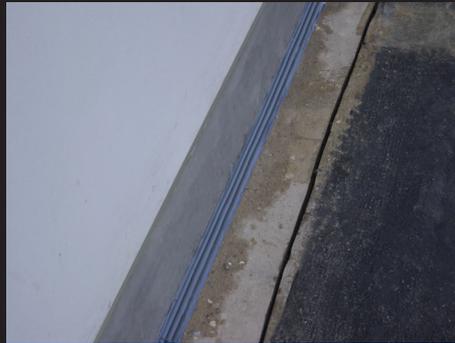
Emseal Movement Joint

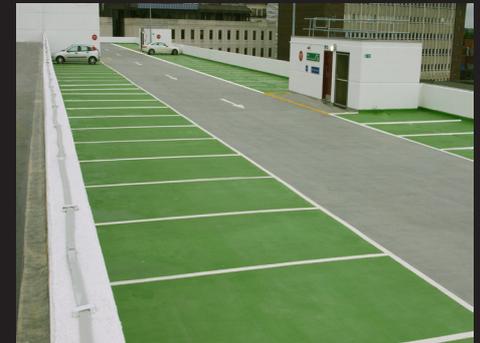
Complete & back in use
