CASE STUDY

Podium Deck Parking at Retail Centres

ASDA Supercentre, Huyton

Steel Frame & Composite Deck Car Park

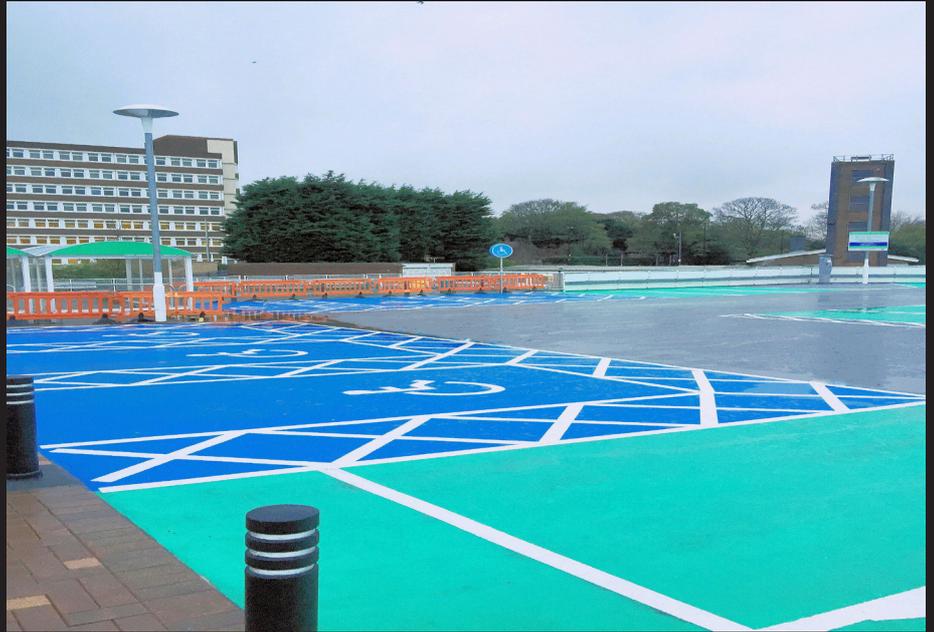
ASDA Huyton is no exception to that problem with a single podium parking deck providing some of its Supercentre’s parking capacity. As with most top deck waterproofing of these types of parking structure, blistering was occurring in areas. These blisters are trapped moisture which is trying to escape and they create dangerous trip hazards across a car park’s surface. Wheel indentation was also another problem.

Makers’ scope of work was to prepare the asphalt deck to remove blistering and make good splits and indents in the asphalt followed by completely re-waterproofing the entire top deck area and vehicle up/down ramp all within a very tight 5-week programme.

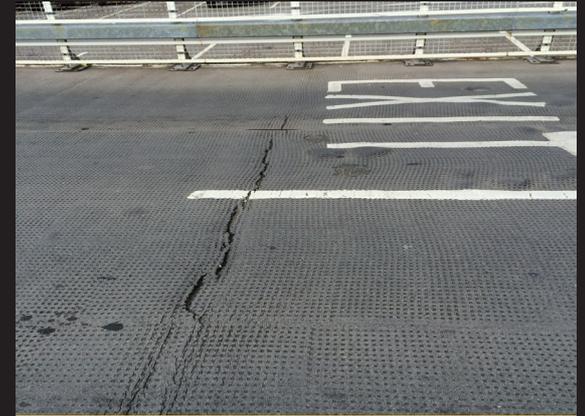
Before

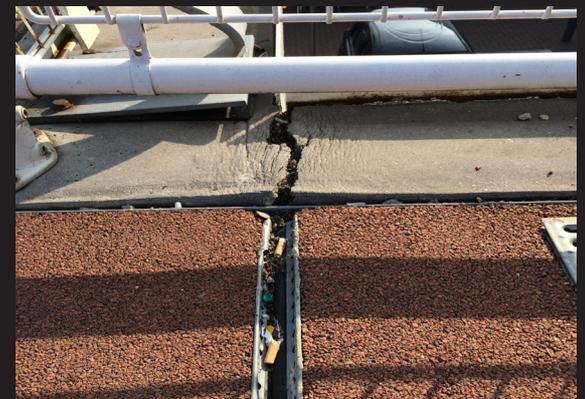
Before

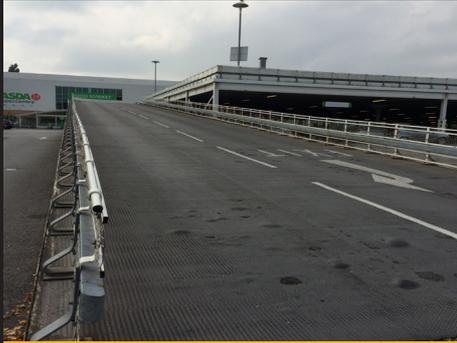
Blisters on Ramp

The asphalt was exhibiting a range of defects; those of blistering as a result of trapped (interstitial) moisture and wheel indentations, where vehicle wheels sink into the asphalt when the weather is hot and the asphalt softens in the daytime heat. The wheel indents also create areas of water ponding which in the wet become a serious slip hazard for vehicles and pedestrians alike.

Following careful planing and substrate preparation of the asphalt, the wheel indents were repaired as were the various splits and cracks in the surface. The prepared substrate was primed with Triflex Cryl Primer followed by the application of Triflex's mesh-reinforced Deckfloor system incorporating quartz aggregate to provide slip resistance.

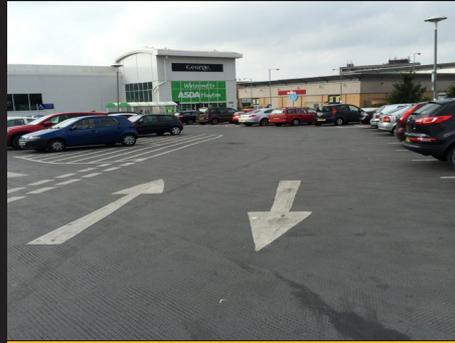
Two-way Traffic Flow

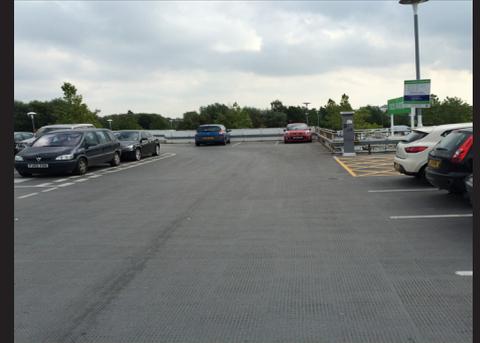
Slip Resistance Issues

The main access ramp at the side of the elevated parking deck and the main parking deck itself was waterproofed with an asphalt waterproof wearing course. Though the top surface of the asphalt was 'dimpled', concerns had been raised for some time as to the slip-resistant properties of the asphalt and the risk of injury to pedestrians and possible damage to shoppers' vehicles were an accident to occur.

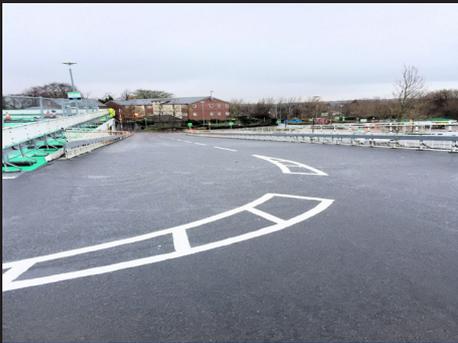
Ramp Fully Repaired

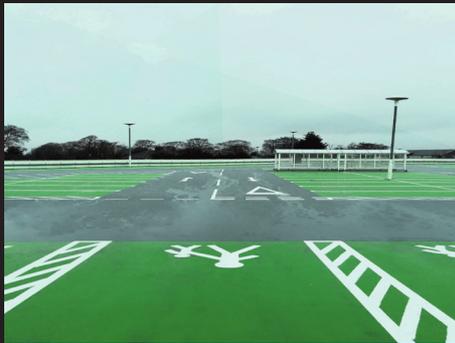
Parent & Child

The deck was finished on contrasting colours to differentiate drive aisles in dark grey and parking bays in bright green including 'Parent & Child' parking bays. Disabled-only user bays have been highlighted in blue.

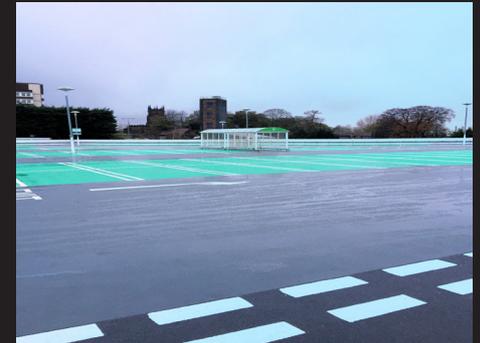
Finished Deck
