# CASE STUDY

## Enhancing Parking Experience at Entertainment Venues

Barclaycard Arena North Car Park

Single Parking Deck

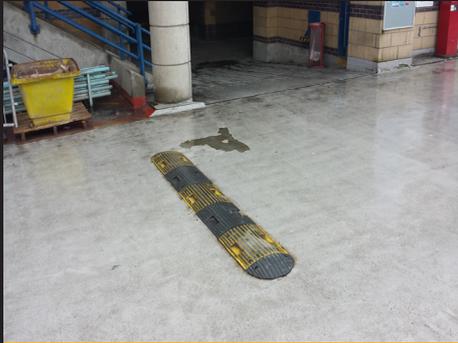
Failed Waterproof

The top deck of the NORTH car park had reached the end of service life and had failed allowing ingress of water and de-icing salts into the parent concrete. This resulted in the development and spread of defects which would require repair prior to re-waterproofing. Following careful preparation of the top deck – split deck levels 8 & 9 – concrete repairs to the parking deck were completed and Triflex's DFS protective Deckfloor system was applied to the whole top deck surface area. All the movement joints were also replaced with the joint-face-adhered Emseal DSM system.

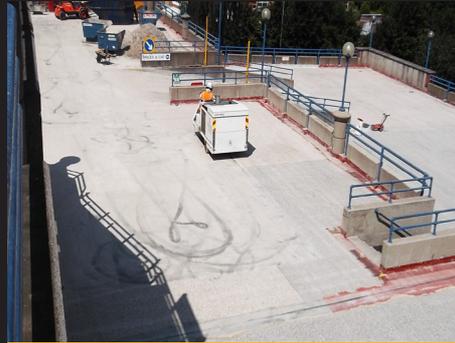
Top Deck Preparation

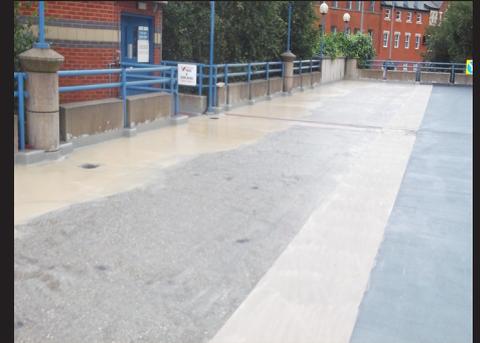
Stages of Waterproofing

The intermediate decks had waterproofing treatments applied to the ramps & turning circles only so the deck surface had to be prepared by captive shot-blasting to remove surface laitance and other contaminants. Again, Triflex's Deckfloor waterproof car park decking system was applied to all deck areas in contrasting colours with drive aisles in dark grey, parking bays in light grey and a new pedestrian walkway highlighted in bright blue. Specially designated areas such as disabled parking or emergency vehicles only were highlighted in red with yellow linemarking and cross-hatching.

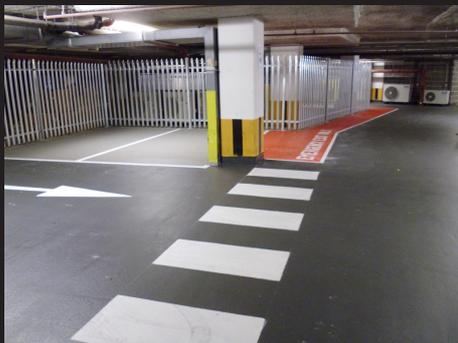
Area Demarcation

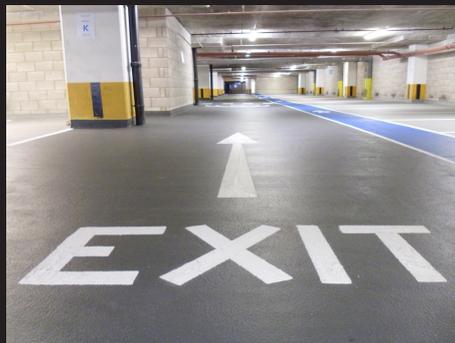
Enhanced Internals

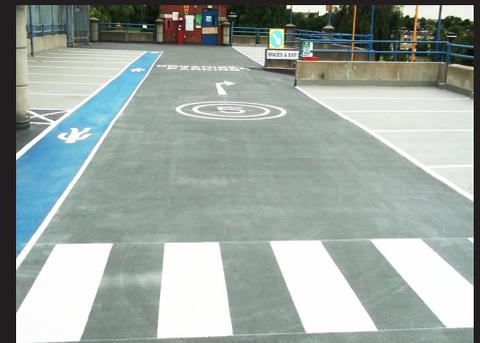
Top Deck Refurbished
