CASE STUDY

Improving Shoppers' Parking Experience

Northfield Shopping Centre
Car Park

Car Park

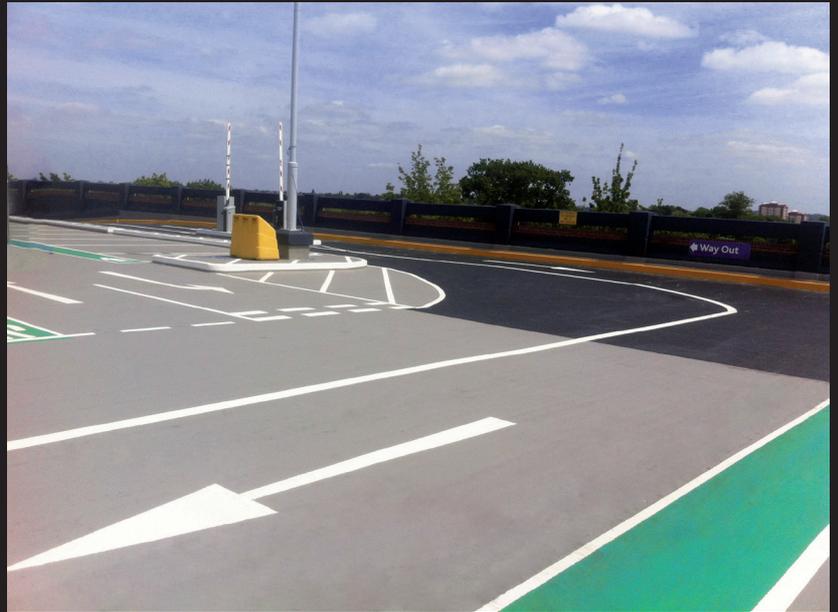
Access up to the car park is via a long ramp to the main open-air podium deck parking area which is directly above Wilkinson's retail store. The parking deck was waterproofed with asphalt which had many splits and cracks which was letting water into the retail space directly below.

The reinforced concrete parapet walls and other structural elements to the ramp were in much need of repair as were the badly leaking movement joints in the ramp's surface which had been patched up many times over the years in an attempt to prevent water getting in.

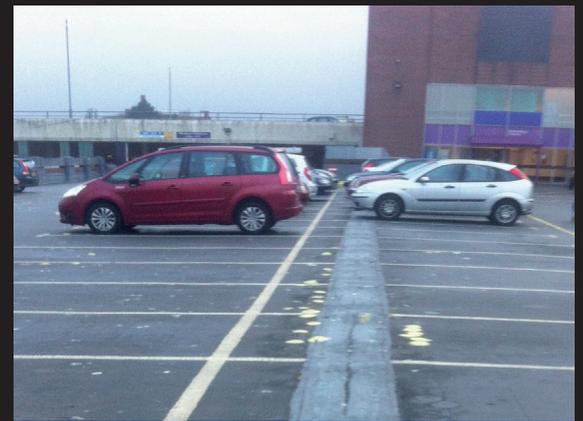
Before

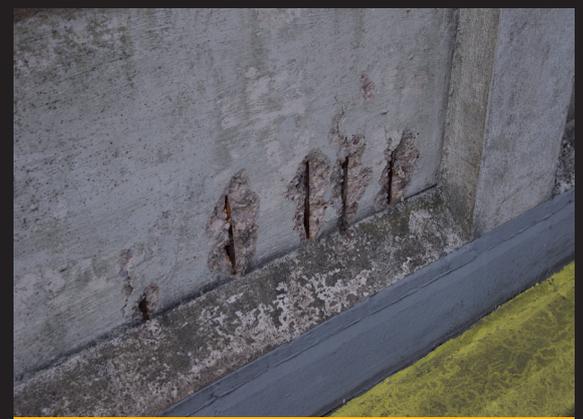
Before

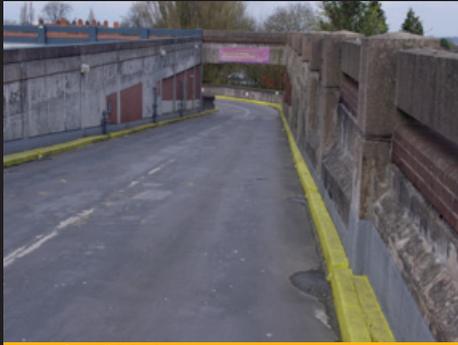
Lack of Maintenance

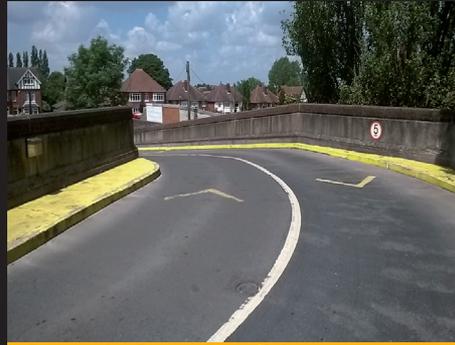
Ramp in Poor Condition

Following reinstatement of the movement joints, these were made watertight with Emseal's DSM watertight car park deck jointing system. The repaired asphalt surface of the main access ramp was re-waterproofed using Triflex's DFS system, a heavy duty wearing layer designed specifically for high-wear areas in car parks. The kerbs were reinstated either side of the ramps with the main entrance and exit barriers replaced as part of the project.

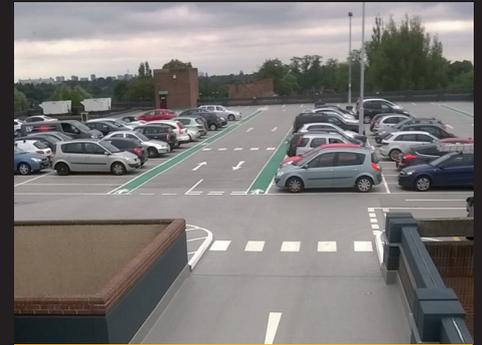
Open Deck Complete

The existing asphalt surface of the exposed parking deck areas had to be prepared by planing to remove many of the imperfections. Once planed, the splits and cracks in the asphalt were repaired including levelling out unsightly wheel divots created by the load impact of car wheels over time. Pre-cast kerbs that had been originally laid along the full length of both sides of the access ramp and sitting on top of the existing asphalt had to be taken up by hand and stored at site in readiness to be put back once the re-waterproofing works were carried out.

Many of the longitudinal daywork joints in the asphalt surface had been badly damaged by constant vehicular traffic. Again, these too had been poorly repaired and patched up over the years culminating in a need to completely cut out the failed areas and reinstate. The damaged asphalt was cut back approximately 100mm either side of the daywork joints and reinstated to original line and level using a fast setting repair mortar. To ensure future water tightness, the re-formed joints were overbanded with a reinforced fleece layer followed by complete encapsulation with Triflex's PRO-Park car park decking system which was applied across the whole of the repaired parking deck.

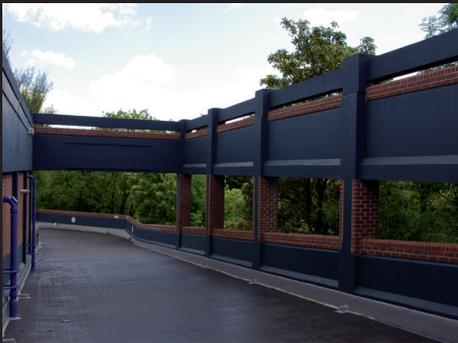
Repaired & Protected

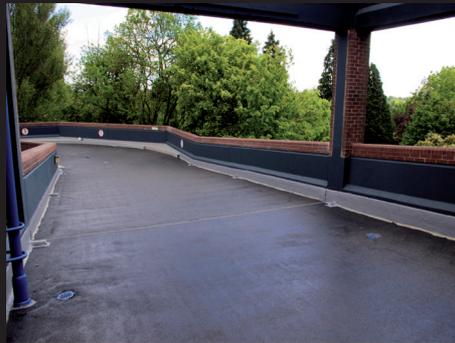
Ramp Transformed

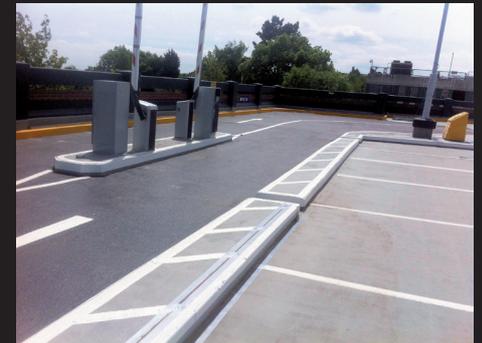
Complete
