CASE STUDY

Footbridge Refurbishment

Westone Bridge, Northampton

Steel Bridge & Concrete Piers

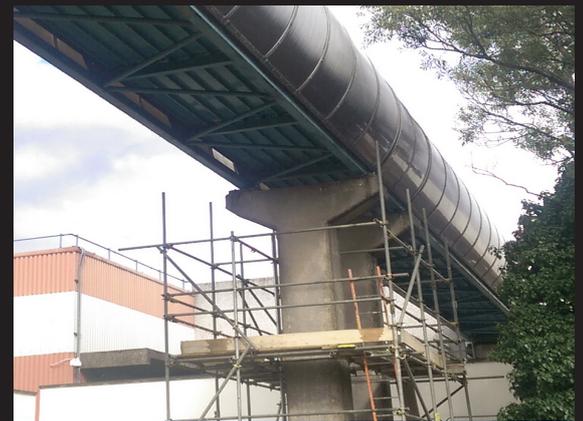
The footbridge structure – built in 1975 - had a domed steel and perspex canopy which enclosed the walkway and had been neglected for many years along with its concrete supports. The design of the structure and its tunnel-like enclosure made it extremely difficult to clean and maintain its exterior both by its physical shape and by virtue of the fact that it crosses a busy public highway that is in constant use.

Before

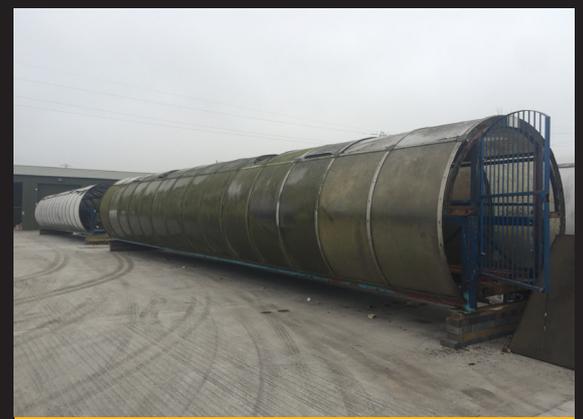
Before

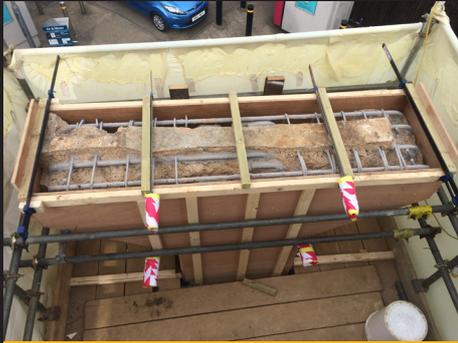
Major Repair to Piers

Following the removal of six of the bridge's steel sections, the remaining 13 in-situ reinforced concrete piers had to undergo substantial concrete repairs having not been afforded the protection from the elements by any protective coatings. Large areas of concrete were broken away from the piers and following surface preparation of the exposed corroding reinforcement, shuttering was built around the tops of the piers and the concrete repaired using Sika's pre-bagged Armorcrete flowable concrete repair mortar. The exposed corner steels on many of the vertical faces of the supporting columns were also repaired using hand-placed, Sika's Monotop concrete repair mortars.

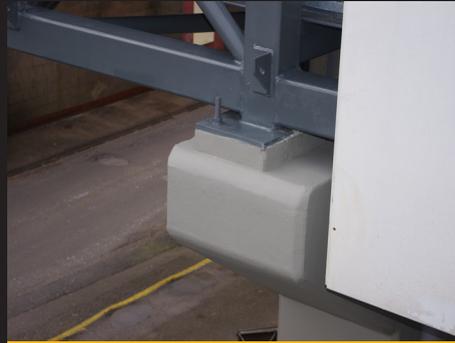
Piers Repaired & Coated

Once repaired – and following the application of Sika's Ferrogard 903 migratory corrosion inhibitor as part of the corrosion management strategy for the concrete elements, Sika's 2mm thick Monotop surface levelling mortar was applied to add additional theoretical concrete cover as well as to mask the repaired areas and provide a suitably smooth surface for the final application of Sika's 550W elastomeric anti-carbonation coating.

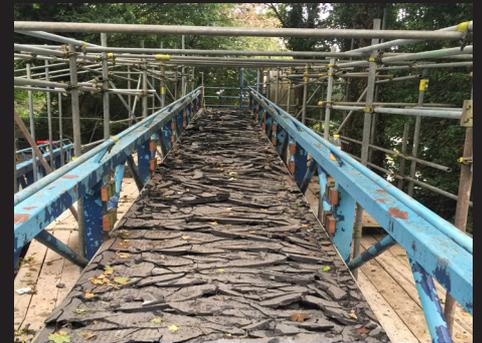
Asphalt Deck Removal

Following removal of the 50mm-thick asphalt wearing course of the footbridge walkways, badly corroded steel members on various sections of the bridge had to be completely removed and replaced. The bridges were then grit-blasted back to bare metal, primed and re-painted with a three-coat Jotun protective paint system. The decks were replaced with a maintenance-free composite decking system. Highways-compliant 'EKKI' hardwood timber rails were fixed the full length both sides of the bridge with a galvanised mesh panel fixed over the top for additional safety. The handrails were also raised 100mm in height along both sides of the bridge to ensure compliance with safety regulations.

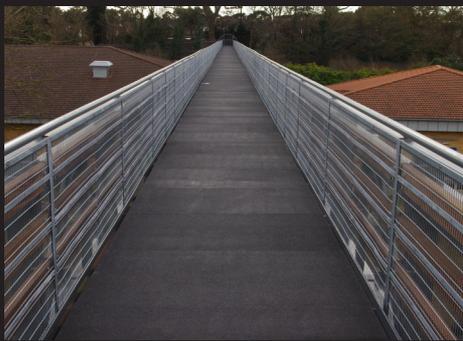
Composite Deck Replacement

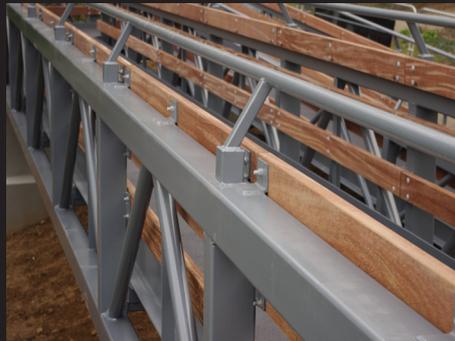
Hand rail increased by 100mm

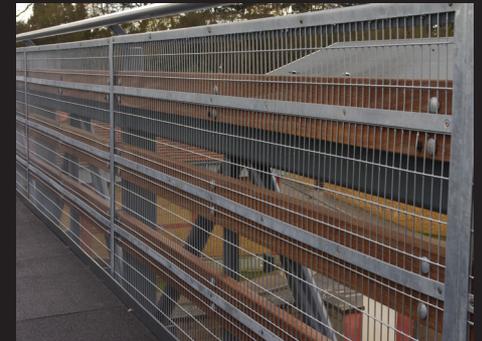
Safety Mesh Installed
