# CASE STUDY

## Spray-applied Deck Waterproofing

Kennet Centre Car Park,  
Newbury

Car Park

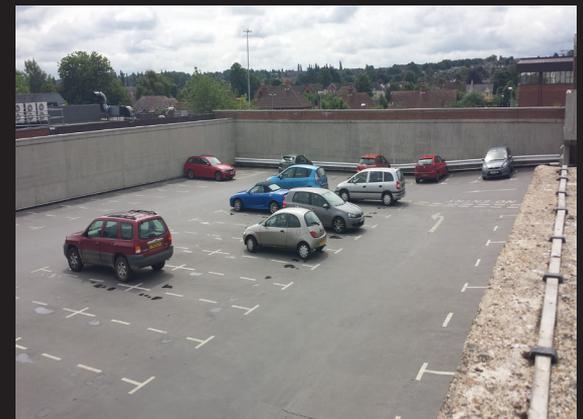
The original asphalt surface of the car park had become defective over its life developing a number of splits and cracked blisters which were allowing water ingress. The asphalt surface on the upper level of the top deck had been previously re-waterproofed with a polyurethane-based car park waterproofing membrane in the past however this had also failed. The asphalt on the lower top deck remained from original construction without any past remedial work.

Before

Makers' package of works was to prepare and repair the existing failed asphalt on the two top decks followed by re-waterproofing with a spray-applied car park deck waterproofing system – Stirling Lloyd's Decseal FR – to the entire area.

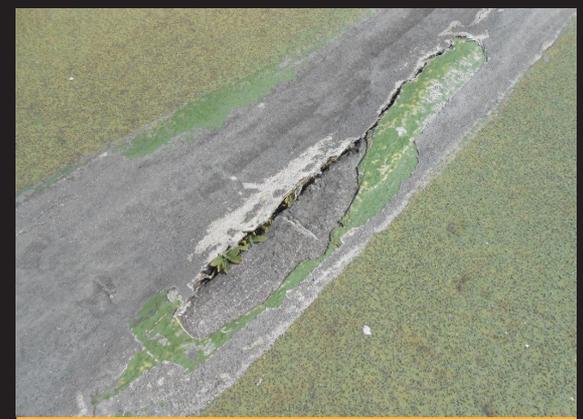
Before

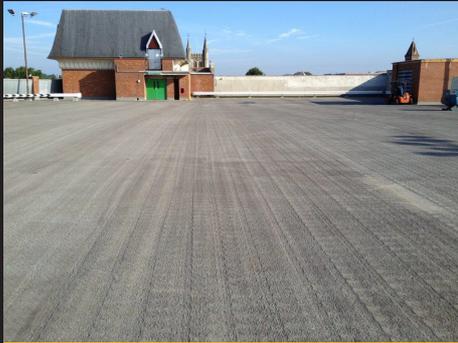
Asphalt Prepared

The existing polyurethane-based waterproof layer that had been applied over the asphalt of the upper top deck had to be removed in its entirety by planing to ensure that the proposed new deck waterproofing system would achieve a 100% adhesive bond to it. The asphalt surface on the lower top deck was also prepared in the same way to ensure a suitable surface for the new waterproofing.

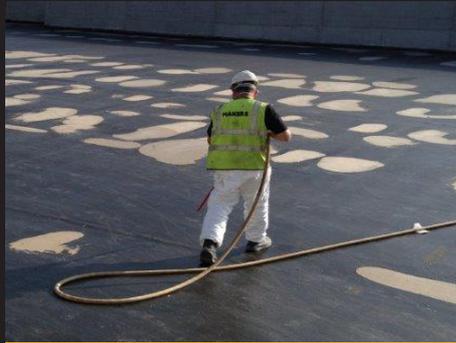
Repairs to Asphalt

Typical of ageing asphalt on car parks are splits to original daywork joints, wheel indentations from vehicles and blistering as a result of trapped moisture. With the various defects highlighted following surface preparation, repairs were carried out using Stirling Lloyd's rapid-curing Metaset surface repair and scratchcoat product prior to the application of the overall Decseal surface primer coat.

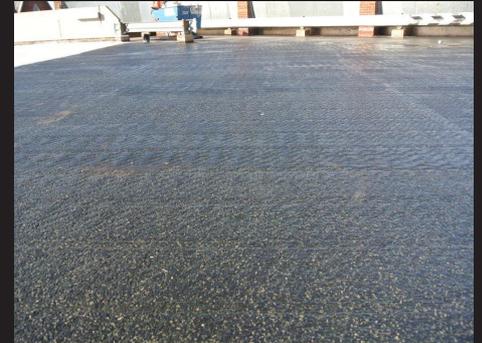
Asphalt Primed

Once the primer had been applied over the prepared and repaired asphalt surface, two fleece-encapsulating layers of Decseal – a cold, liquid-applied waterproofing system – were applied by spray to incorporate the additional reinforcement needed over the existing substrate. The advantage of spray-application means that the works can be completed with minimal downtime.

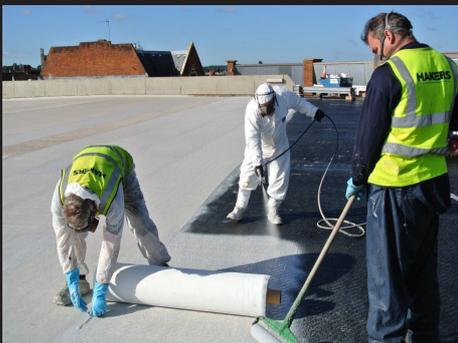
Base Coat & Fleece

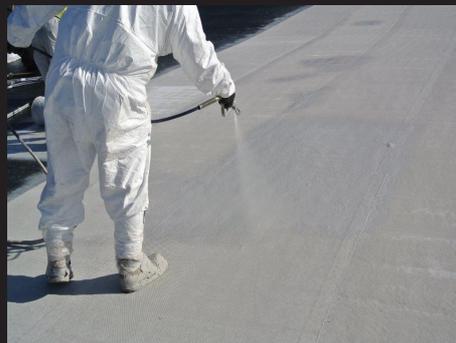
Encapsulating Layer

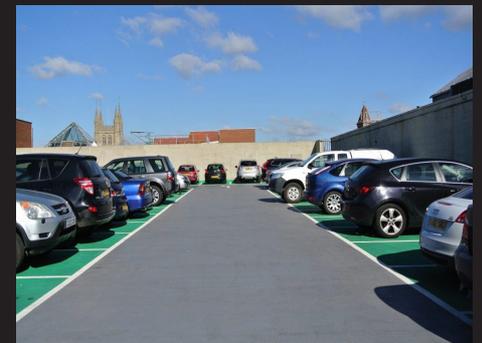
Coloured Seal Coats

A coloured and slip-resistant seal coat of Decseal was then applied to the overall surface highlighting the drive aisles in grey with the parking bays in green. Bay markings, flow arrows and instructions were finally applied to finish.
