CASE STUDY

External Fabric Repair of an MSCP

The Grosvenor Shopping Centre Car Park

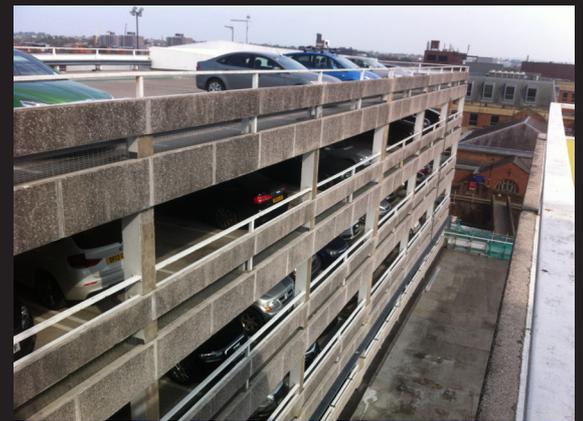
Before

Constructed In the late 1970's this reinforced concrete, five storey split level car park with approximately 410 parking spaces had been suffering with a long term lack of maintenance. It had reached a point where a number of defects had appeared and required some structural evaluation and repairs to the structure were required.

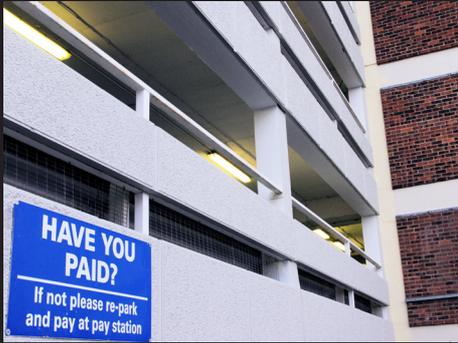
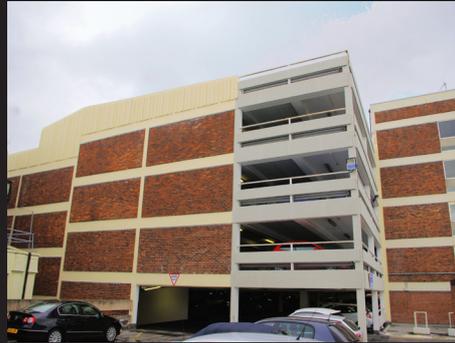
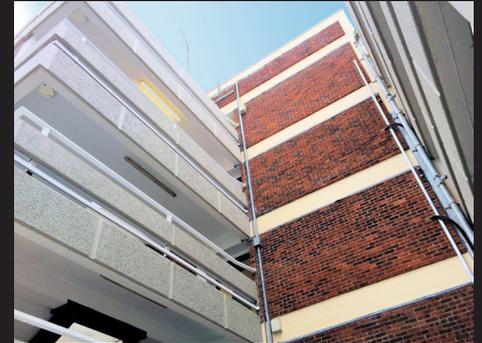
After a full report to the defects to the external panels. Makers were appointed to undertake the repairs and apply corrosion inhibitors to protect the insitu structural elements. Repairs were to three number of elevations and to external stair cores which had become worn over the years.

Works were carried out by scaffolding and the use of cradles, the aggregate panels were high pressured washed along with the inside edge beam to remove previous latents of MCI in preparation for the application of the migration corrosion inhibitors. Water repellent Sikagard 700s Aquastop was applied to the brickwork making it water tight to withstand heavy winters.

Concrete repairs were carried out to the External Elevations, panels, beam and columns and Sika Ferrogard 903 migration corrosion inhibitors was applied to all exposed concrete surfaces. Application of Sikagard 550w was then applied and finished in a stipple effect to recreate the original aggregate panel profile.
