STRUCTURES CASE STUDY

Remedial Deck Repairs and Waterproofing

IKEA - Leeds

Car Park

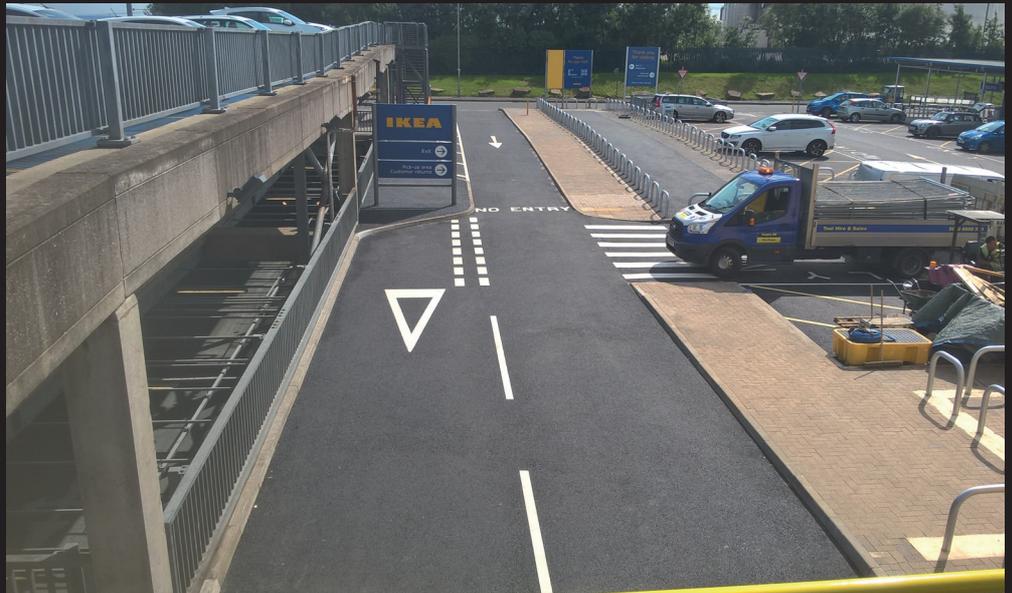
The below ground car park was suffering with major water ingress through the existing asphalt surface. After testing and investigation had been carried out it was established that the asphalt had become very weak and was not bonded to the concrete deck. The water was able to penetrate through the slab and had caused severe corrosion in the steel shuttering below.

The car park entrance road, pavements and block paving were identified as the areas in need of waterproofing. Once Makers were appointed to carry out the work the car park entrance was cordoned off, using traffic management Makers were able to keep the top deck of the car park in use. Makers then proceeded to strip back all the surface finishes, existing asphalt, barriers, paving and kerb's.

The identified areas of corroded metal deck were cut and removed from the soffit ready for the necessary concrete repairs. The areas of damaged concrete were cut out using diamond blade discs then reinstated using rapid repair mortar.
