CASE STUDY

Concrete Repairs and Deck Waterproofing

Kingsmead Shopping Centre
Multi-Storey Car Park

In-Situ reinforced concrete
frame with coffered slabs

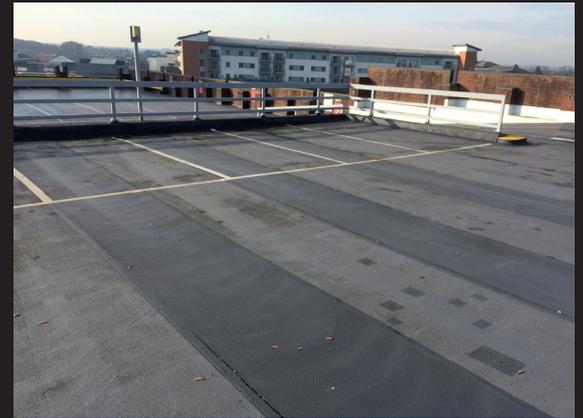
The car park was suffering significant leakage from the soffit of the top deck; upper and lower deck of level 5, leaking through to the lower deck 4 below. The Asphalt from the previous refurbishment back in 2012 – 13 had started to crack and de-bond in areas with waterproofing membrane peeling. This allowed water ingress to the concrete surface and with defective day joints in the asphalt; was providing a pathway for water to penetrate through to the lower deck.

Before

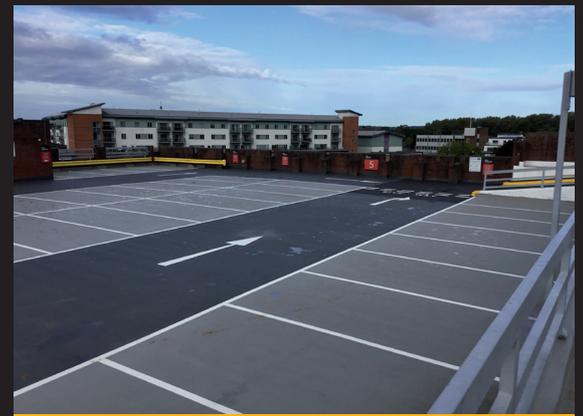
After

The total area of deck coverage was 3555m² and once planed and reinforced was coated with the decking system Triflex Propark HD a fully reinforced car park deck system to existing asphalt substrate which gives a 10-year warranty.

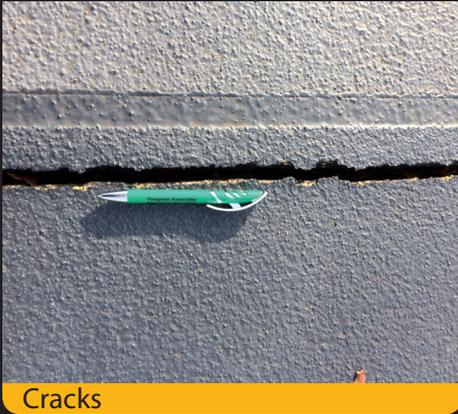
An investigation by Sandberg revealed that the refurbishment in 2012-13 which consisted of a RESDEV Deckmaster R waterproofing system was insufficient as cracks in the soffits and deck had formed and was providing a pathway for seepage.

Cracks

The investigation identified that there was a failure to lap the joints as the cracks were long and wide linear cracks and were always associated with joints in the mastic asphalt substrate. The width of the cracks were far in excess of the bridging properties of the RESDEV Deckmaster system and therefore failed to remedy the problems after refurbishment.

The defective day joints were removed with the installation of new joints which were reinforced with fleece along with any identified cracks, providing a bridging capability of up to 0.5mm crack width.

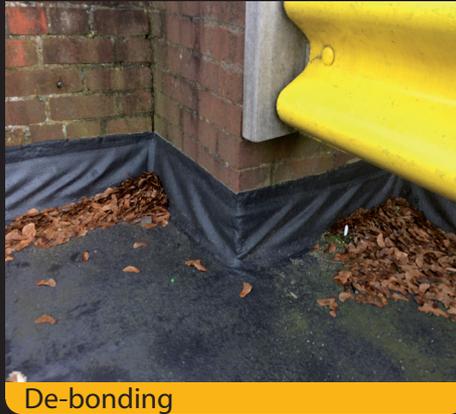
De-bonding

Preparation of the deck was required and so the top deck was planed to remove the existing resin coating and also 5mm of the asphalt, this included a walkway and undercover stairwell to lift lobby.

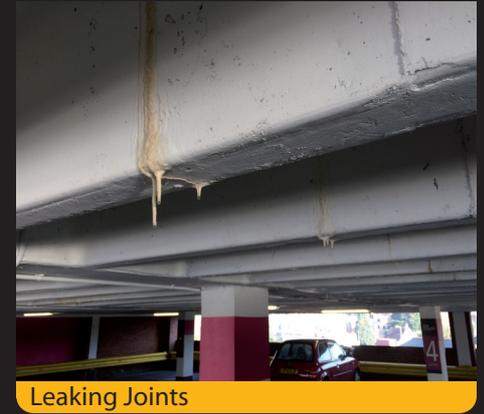
Leaking Joints

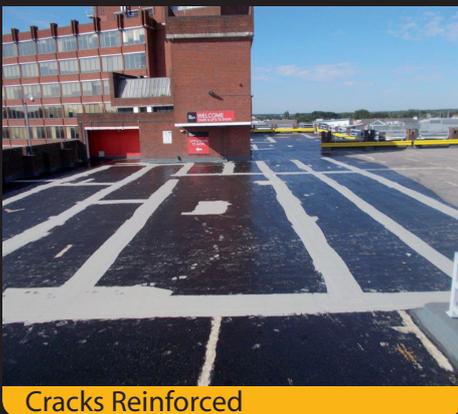
Cracks Reinforced

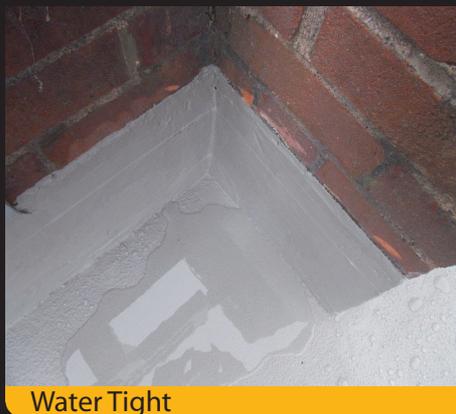
Water Tight

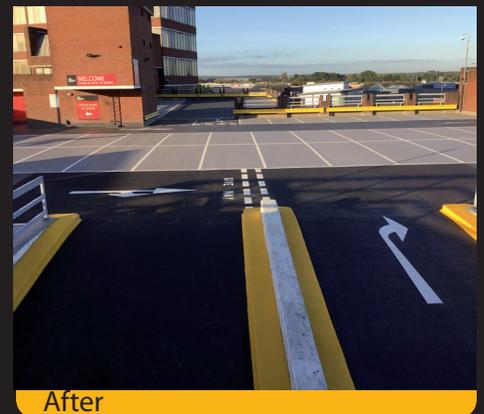
After
