# CASE STUDY

## Deck Waterproofing

Middleton Shopping Centre  
Car Park

Top Deck Car Park

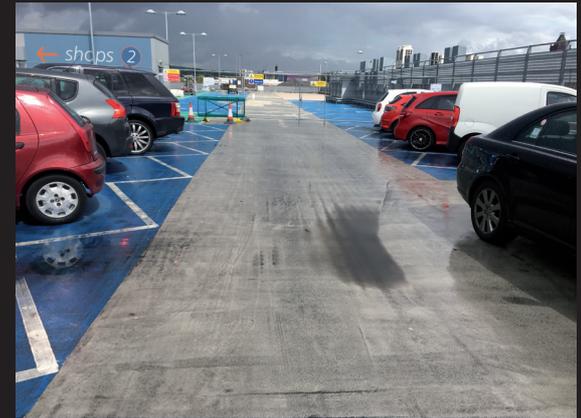
Before

The top deck car park is located above the shopping centre and was suffering from ponding and drainage issues which was caused by uneven substrate. There was a lift shaft which serviced the store below which was no longer in operation but allowing water ingress down the shaft into the store.

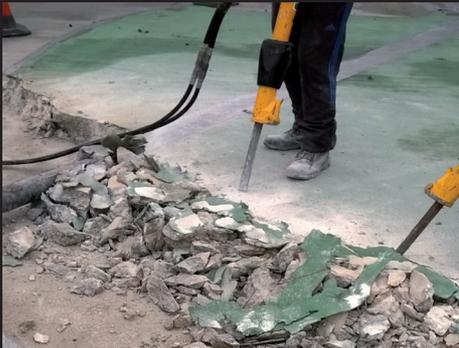
Removal of islands

With the new proposed layout, the existing diagonal line markings were removed and there were islands which were no longer required and therefore removed, this also required investigation and repairs to drainage channels prior to deck repairs.

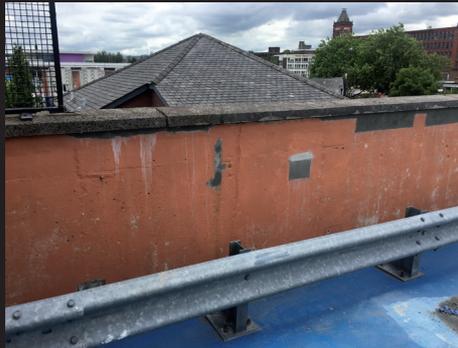
Parapet Walls Repaired

All loose fixtures and fitting were removed and the parapet walls and coping stones were jet washed ready for concrete repair and painting and redecoration of rendering. Installation of capping details to existing coping stones and the removal of redundant barriers and re-instatement of new barriers were carried out.

Sika Monotop 615 was used for the concrete repairs and Dulux Smooth Masonry paint applied to parapet walls.

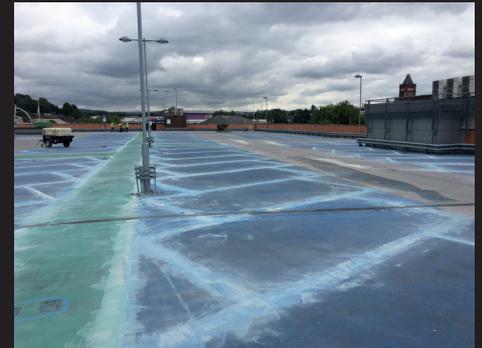
Line Markings Removed
