# **CASE STUDY**

## School Roof Refurbishment

Highfurlong Special School

School Roof

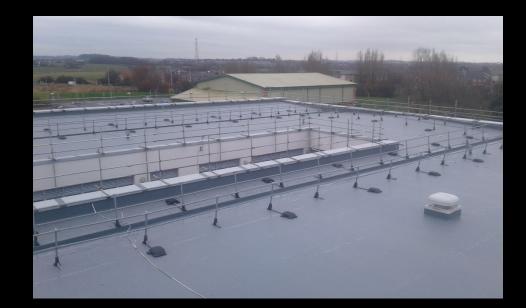
Highfurlong School is a state of the art, purpose-built school located in the North of Blackpool, Pupils come from Blackpool, Wyre and Fylde and in some cases further afield to access the special education provision that is on offer. Construction commenced on site in April 2014, to create 2 schools, Blackpool Aspire Academy and Highfurlong special School.

Carillion, the main contractor on this project selected a single ply waterproofing layer as the roof finish. Although finished in 2015 the special school wouldn't sign off the building due to the roof leaking in numerous places. Carillion along with their selected roofing contractor failed to make the roof water tight, these issues carried on for a further 3 years until the collapse of Carillion happened which also took the roofing contractor down with them. The leaks had got so bad that the councils only option was to completely replace the waterproofing layer of the roof.

With the work planned to run into term time we selected Triflex's fully reinforced Protect cold applied liquid system, using the existing single ply as the substrate we could simply overlay the failed roof, causing no disruption to the school below.

The metal capping's to the external perimeter were a cause of concern, butted together and sealed with a silicone bead, over time this bead perished and could be exacerbating the water ingress issues. All the joints were cleaned, primed, banded and sealed using Triflex's ProDetail system. A large central valley gutter was given special attention as this was one of the major areas of leaking. 100's of single ply joints were leaking into the sensory room below. This room was full of expensive audio-visual equipment which had to be moved around/covered in heavy downpours.
