CASE STUDY

Structural Refurbishment

Weston College

Cast in-situ, Steel Reinforced Concrete Frame & Panels

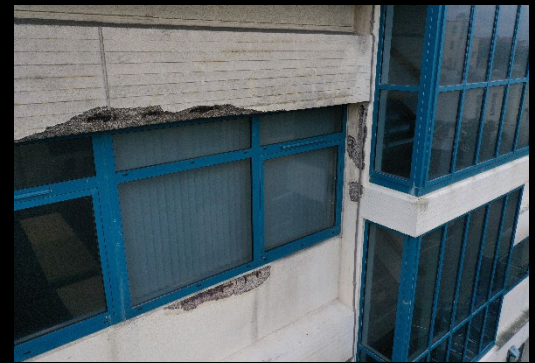
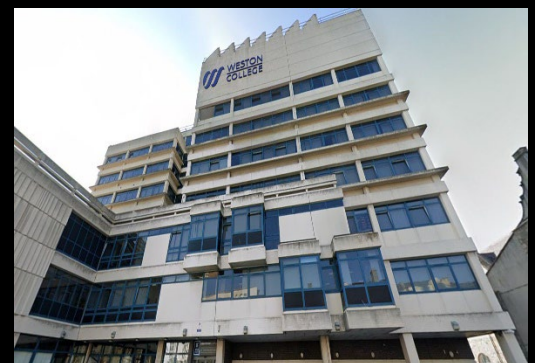
Many areas, including all of the original building, were coated in anti-carbonation coating, but over the years its façades have degraded with the corrosive salt air, and in time has caused spalling from lintels, vertical jambs and window sills exposing the reinforced bars. Its original cream colour had lost its shine and was lacklustre.

Before

All external elevations were pressure washed to remove any deleterious materials followed by the breakout of any spalling concrete and areas which were in need of repair. Any exposed steels were prepared to ST3 standards and then coated with Fosroc Nitoprime Zincrich Plus to protect the reinforcement.

The concrete repairs were carried out using Fosroc Renderoc HB30; a high performance fibre reinforced lightweight mortar that is specifically engineered for vertical and overhead repair work. Nitoseal MS100 joint sealant was used around the windows and joints as it is a one-part, primerless, damp tolerant, non-staining façade sealant producing a tough, durable elastomeric seal. Ideal for structures like this in coastal locations.

Once all concrete repairs were carried out on the college, the structure was coated in Fosroc Dekguard S which was a bespoke colour match to the original cream colour scheme. This provides protection to the concrete and masonry against atmospheric exposure from acid gases, chloride ions, sulphates, oxygen and water.

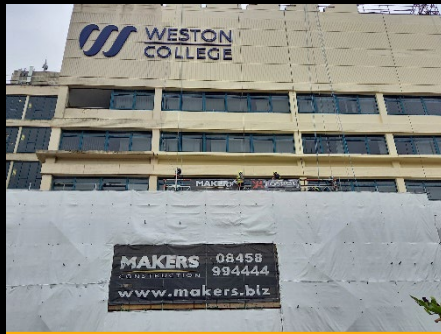
During Pressure Wash

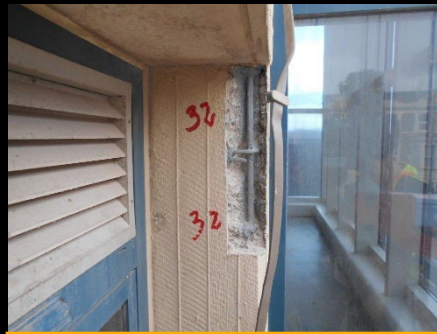
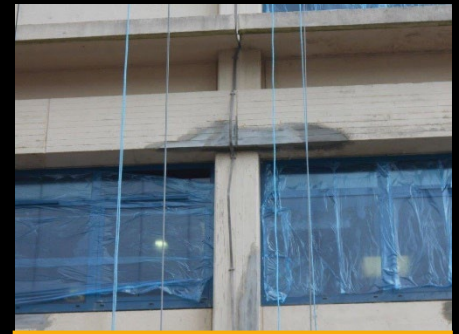
During

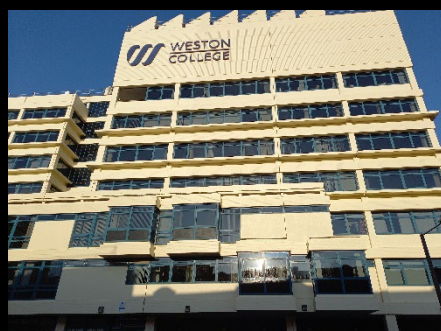
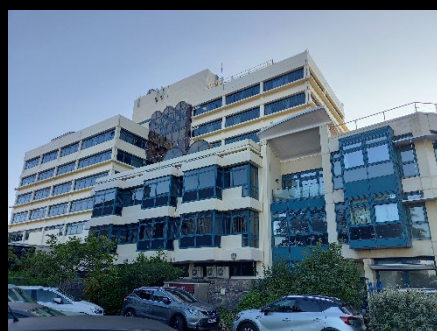
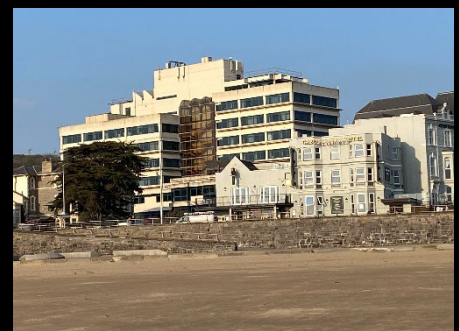
After

This structure is now repaired and refreshed and is protected from the elements for many years to come.
