Roof Refurbishment

MAIN STAND CHELTENHAM RACECOURSE

CONCRETE BARREL ROOFS

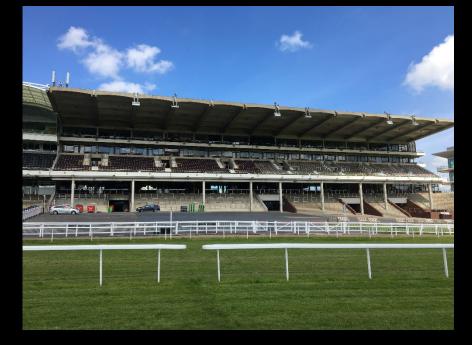
The Jockey Club engaged Makers Construction to carry out a survey on the Main Stand Roof. The unique cantilevered reinforced concrete barrel roofs had visible signs of water ingress due to existing coatings failing allowing water to penetrate and to corrode the steel rebar within the concrete. Left untreated this could in time cause the roof structure to fail. There were also issues with water ingress in to the buildings and on to the punters below. Makers engaged Polyroof Products to carry out testing and produce a specification for the project. Polyroofs Protec flexible hybrid polymer was the selected product to carry out this 2300m2 overlay project.
